MEMORANDUM

SUBJECT: Review, discuss and possibly approve a design services contract for the Mountain Golf Cart Path Replacement Project – Fund: Community Services; Division: Golf; CIP# 3241LI1903; Vendor: Lumos and Associates in the amount of \$75,100

DATE: March 1, 2021

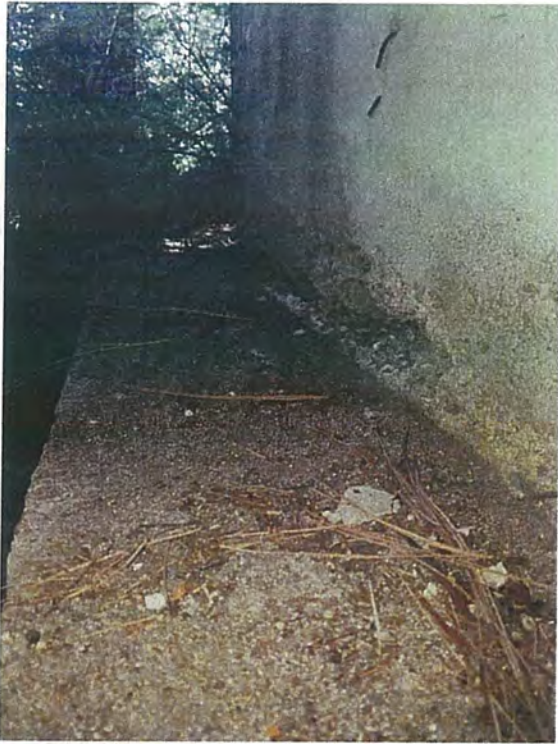
At the west abutment there is scouring beneath the abutment wall footing where the soil beneath the footing has been washed away, see Photos 3 and 4. Also at the west abutment, there is some concrete spalling at the abutment wall at the footing transition, see Photo 5. No scouring was observed at the east abutment.

Photo 4 – Scour at West Abutment Footing

The scouring condition below the abutment footings at the west abutment wall at the 2nd Hole Bridge and at the east abutment wall at the 16th Tee bridge should be repaired as soon as possible. Typically, this is done by placing a low strength concrete flowable fill beneath the footings to replace the washed away soil. The flowable fill is capable of filling all voids in the hard to reach places beneath the footing at the washed out areas.

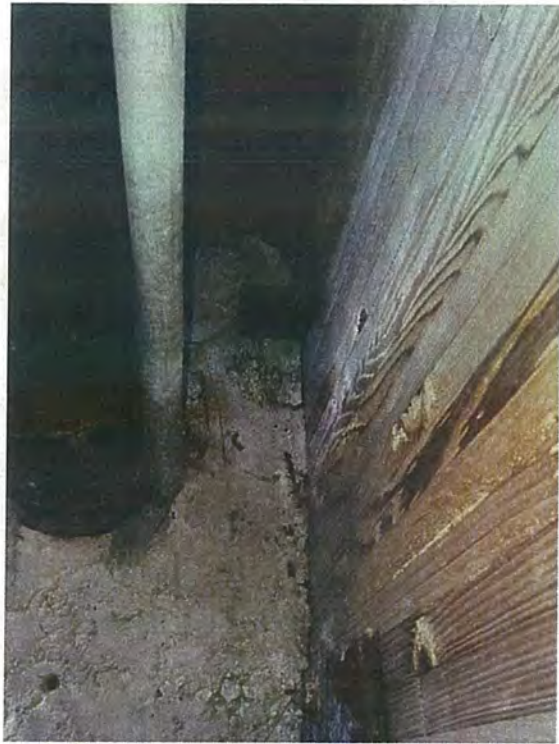
Photo 5 – Spalling at West Abutment Wall

The cracks at the concrete aprons at the 2nd hole bridge should be sealed with an epoxy injection resin. The spalled concrete at the aprons and abutment walls should be patched.

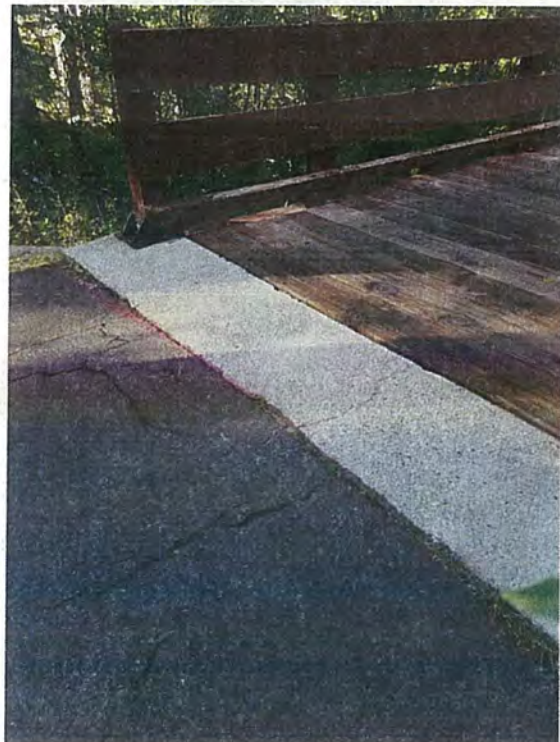
At the west abutment concrete apron there is some minor cracking and spalling of the concrete at the surface of this transition between the cart path and the bridge deck, see Photo 7. At the east abutment apron there is a crack occurring at the middle of the apron, see Photo 8.

Photo 7 – Cracking and Spalling at West
Abutment Approach Apron

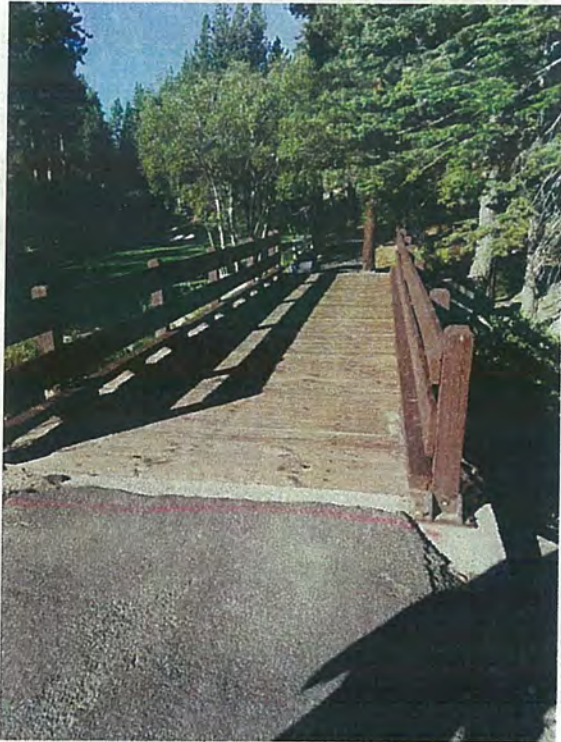
Photo 8 – Crack at East Abutment Approach
Apron

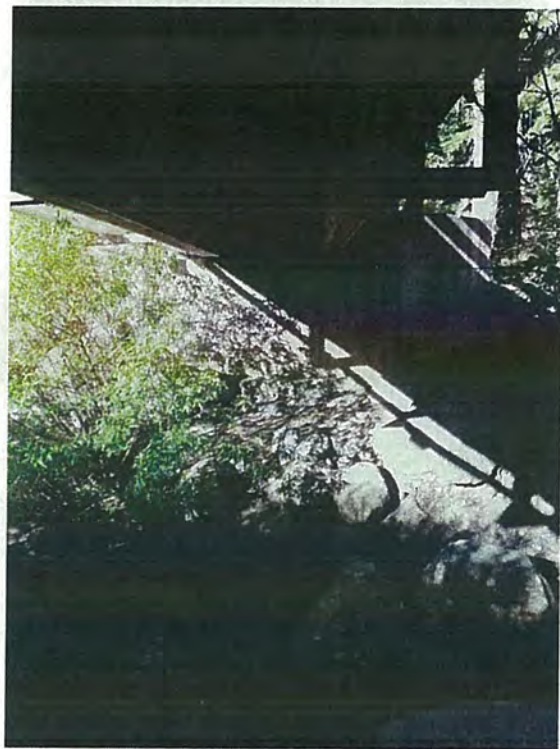
At the northeast abutment apron there is a post base connection that is experiencing slight corrosion. In addition, there is a missing anchor bolt and untightened nuts at this connection, see Photo 11.

Photo 11 – Slight Corrosion/Missing Anchor Bolt

The missing anchor bolt at the 4th Hole Bridge should be replaced with a new bolt drilled and epoxied into the concrete apron. In addition, the missing lag bolts at the 16th Tee post to base plate assemblies should be installed.

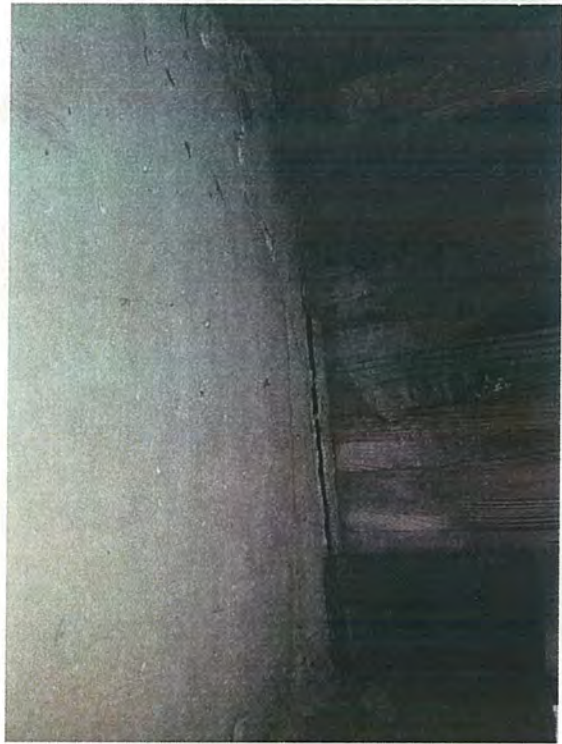
The steel plate beam bearing connections at each of the abutments are in good condition and are experiencing only minor corrosion. At the south beam bearing location there is a steel angle connection at the top of the beam to the abutment wall that is experiencing some minor concrete spalling, see Photo 14.

Photo 14 – Spalling at Top Connection at South End Beam Bearing

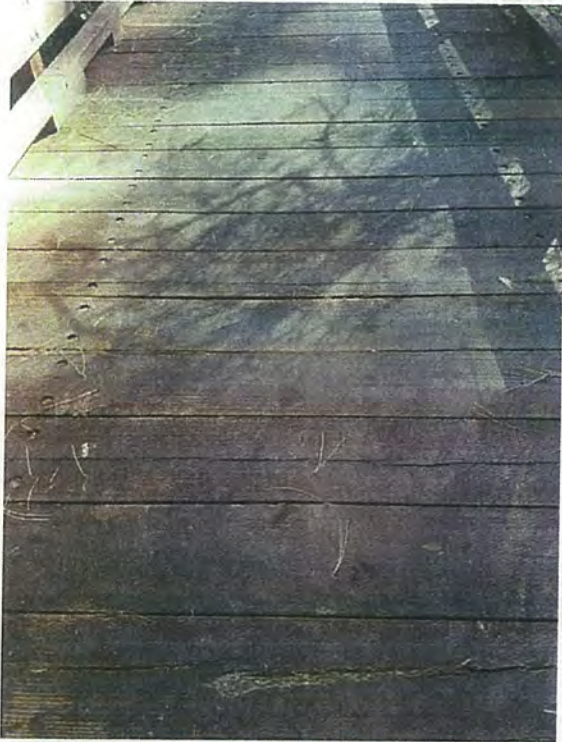
Overall, the bridge superstructure components are in good condition, see Photos 15-18. The planks are experiencing slight to moderate wear (Photo 19) and the glued-laminated beams are moderately weathered (Photo 17). The steel plate beam bearing connections at each abutment are in good condition and are experiencing only minor corrosion.

Photo 19 – Wearing at Deck Surface

In general, the bridges are all in good condition with most of the repairs being deferred maintenance repairs that can be done at the owner's discretion. We would recommend that the wood superstructure elements be provided with protective coatings. For the glued-laminated beams; a clear or colored penetrating epoxy sealer, and for the deck planks, posts, railing, and curb an exterior paint or stain can be used.

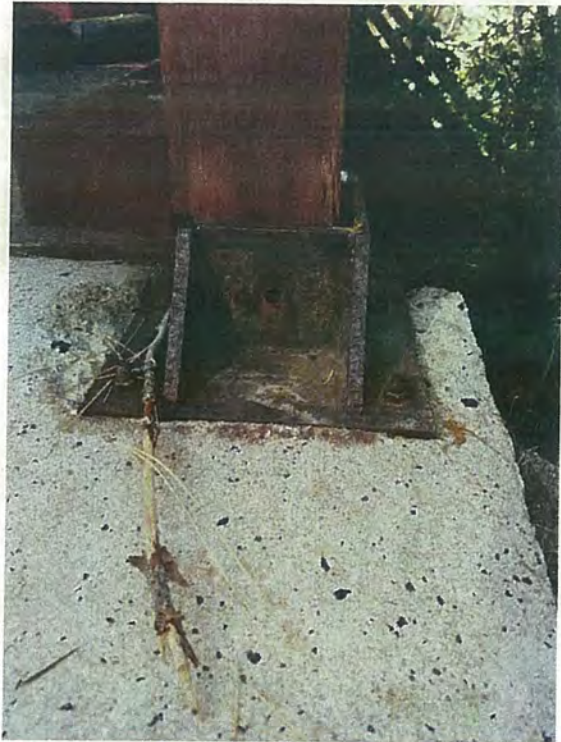
At two of the post base plate connections at the concrete apron locations there are missing lag bolts to connect the post to the base plate assembly, see Photos 20 and 21.

Photo 20 – Missing Bolt at End Post Connection

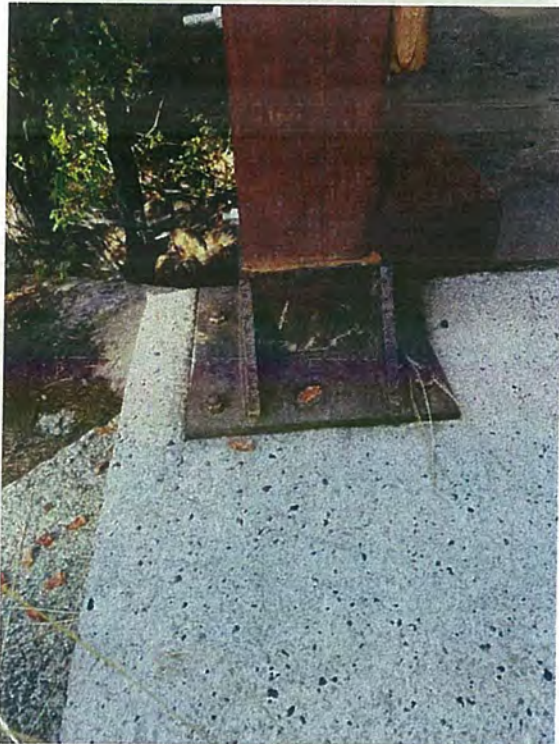
Photo 21 – Missing Bolt at End Post Connection

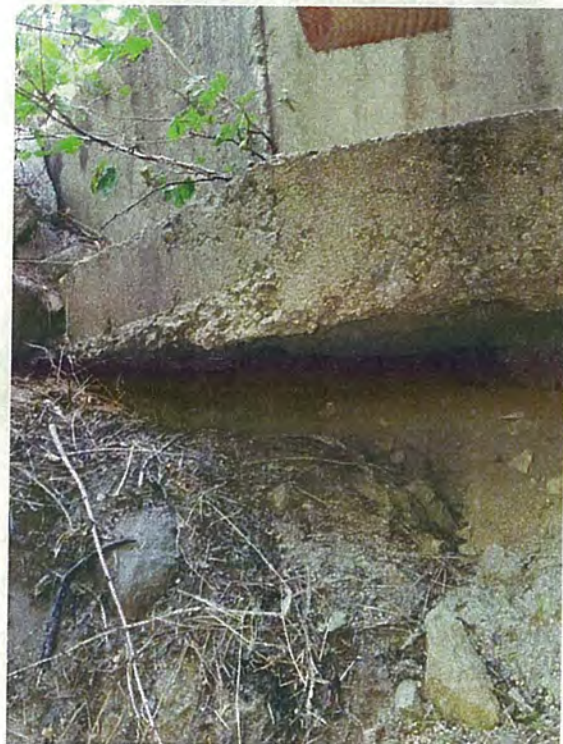
At the east abutment there is severe scouring beneath the abutment wall footing where approximately 3 feet of the soil beneath the footing has been washed away, see Photo 22. No scouring was observed at the west abutment.

Photo 22 – Severe Scour at East Abutment

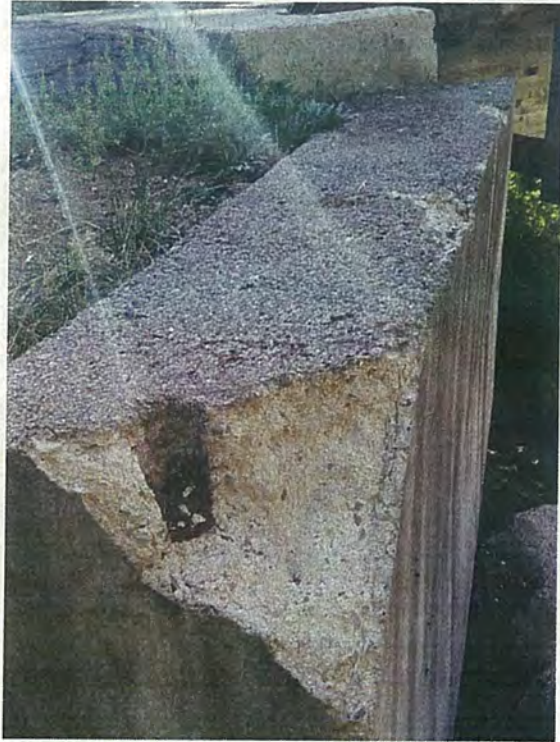
At the northwest abutment wing wall there is a significant amount of concrete spalling that has occurred at the end of the wall. It appears that at some point in time there was a steel post at this location that was impacted causing the spalling to occur, see Photo 24.

Photo 24 – Spalling at Northwest Wing Wall

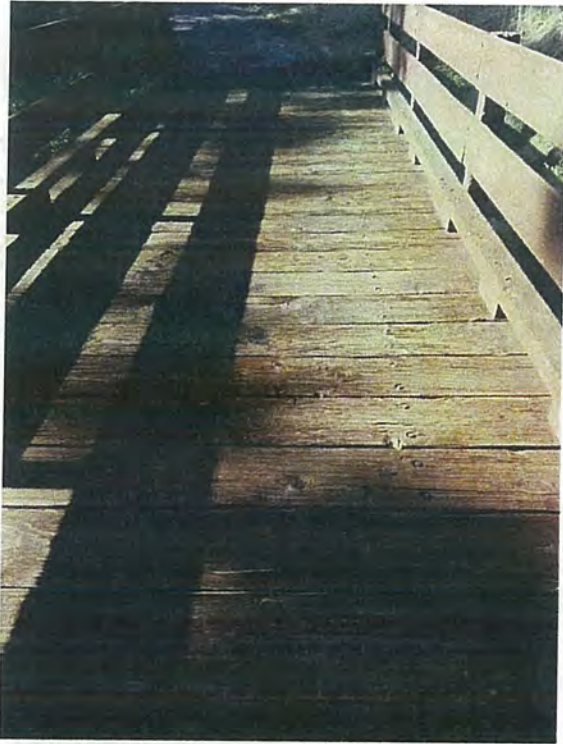
Overall, the bridge superstructure components are in good condition, see Photo 23. The planks are experiencing moderate wear (Photo 27) and the glued-laminated beams are moderately weathered (Photos 28 and 29).

Photo 27 – Moderate Wearing at Deck Surface

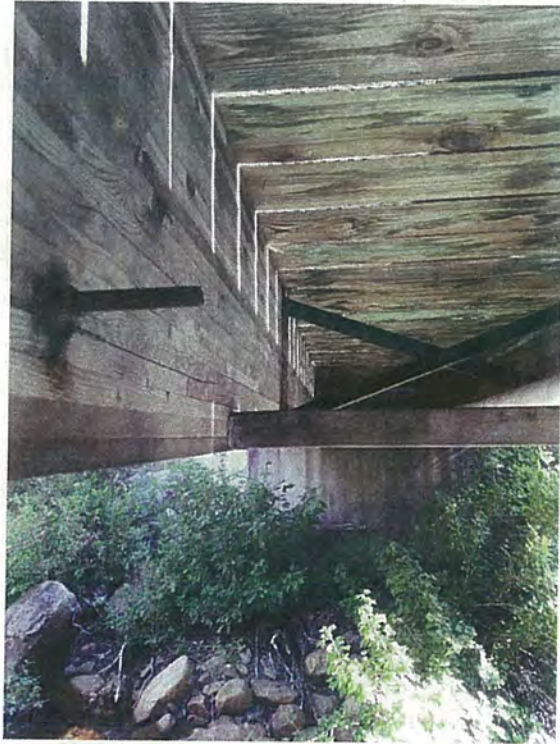
Photo 28 – Typical Weathering at Beams

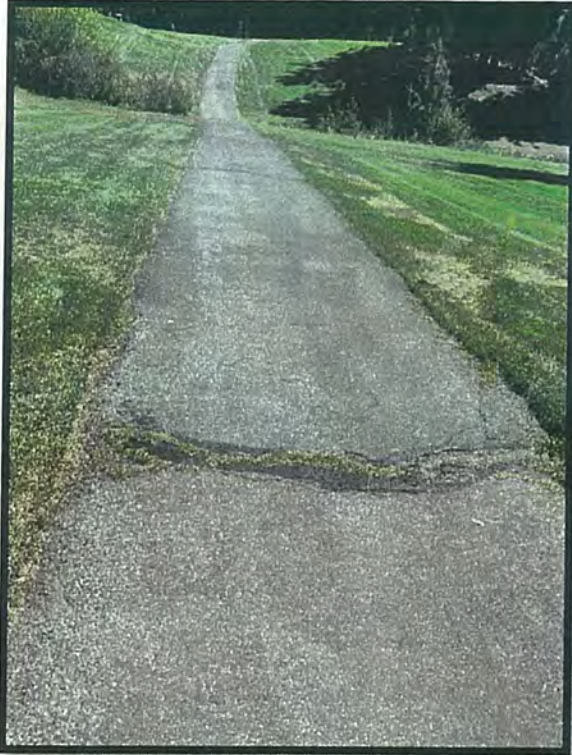
<p>Location</p> <ul style="list-style-type: none"> • Hole 1 <p>Pavement Distress</p> <ul style="list-style-type: none"> • High severity transverse cracking <p>Ride Quality</p> <ul style="list-style-type: none"> • Very poor <p>Safety Concern</p> <ul style="list-style-type: none"> • Low <p>Length of Distress</p> <ul style="list-style-type: none"> • 3-ft <p>Recommended Repair</p> <ul style="list-style-type: none"> • Pavement Reconstruction <p>Estimated Cost</p> <ul style="list-style-type: none"> • Unit Price - \$15 / SF • 3-ft L x 8-ft W • \$360
--

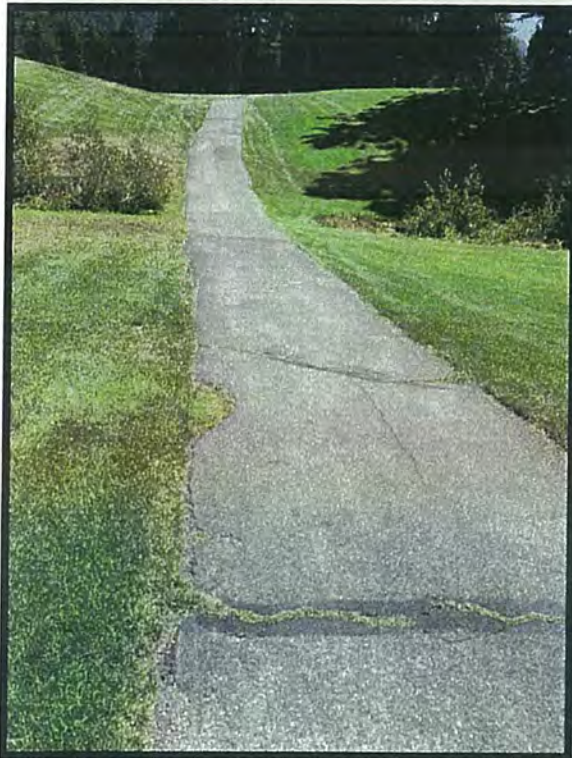
<p>Location</p> <ul style="list-style-type: none"> • Hole 1 <p>Pavement Distress</p> <ul style="list-style-type: none"> • Medium severity transverse cracking • Medium severity edge cracking <p>Ride Quality</p> <ul style="list-style-type: none"> • Poor <p>Safety Concern</p> <ul style="list-style-type: none"> • Low <p>Length of Distress</p> <ul style="list-style-type: none"> • 10-ft <p>Recommended Repair</p> <ul style="list-style-type: none"> • Pavement Reconstruction <p>Estimated Cost</p> <ul style="list-style-type: none"> • Unit Price - \$15 / SF • 10-ft L x 8-ft W • \$1,200
--

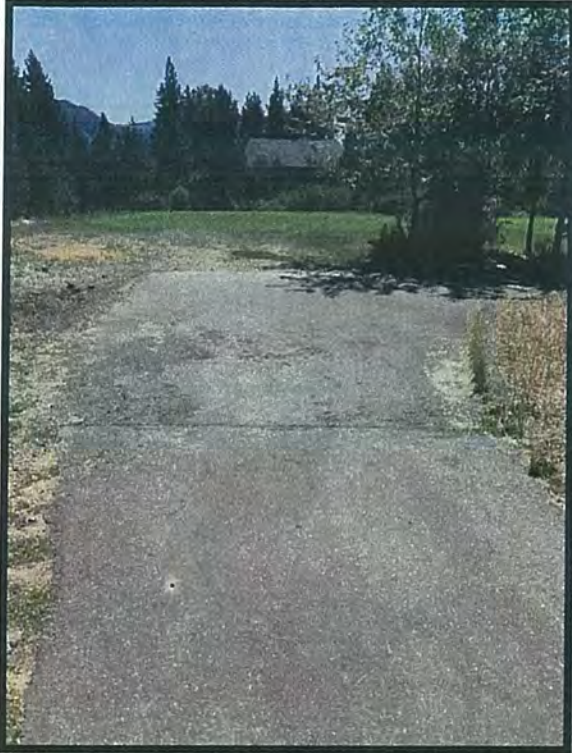
<p>Location</p> <ul style="list-style-type: none"> • Hole 3/4 <p>Pavement Distress</p> <ul style="list-style-type: none"> • High severity raveling <p>Ride Quality</p> <ul style="list-style-type: none"> • Mediocre <p>Safety Concern</p> <ul style="list-style-type: none"> • Low <p>Length of Distress</p> <ul style="list-style-type: none"> • 80-ft <p>Recommended Repair</p> <ul style="list-style-type: none"> • Pavement Reconstruction <p>Estimated Cost</p> <ul style="list-style-type: none"> • Unit Price - \$15 / SF • 20-ft L x 20-ft W + 60-ft L x 8-ft W • \$13,200

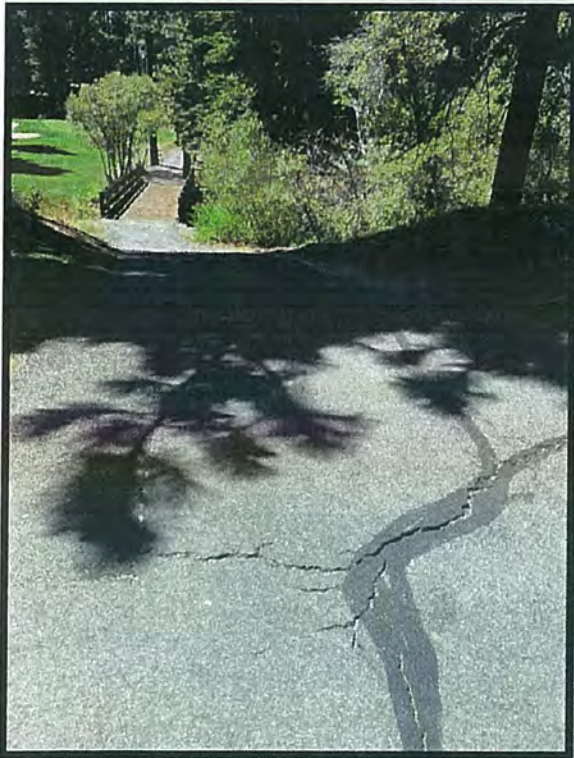
<p>Location</p> <ul style="list-style-type: none"> • Hole 4 <p>Pavement Distress</p> <ul style="list-style-type: none"> • High severity transverse cracking (caused by tree roots) <p>Ride Quality</p> <ul style="list-style-type: none"> • Poor <p>Safety Concern</p> <ul style="list-style-type: none"> • Low <p>Length of Distress</p> <ul style="list-style-type: none"> • See above <p>Recommended Repair</p> <ul style="list-style-type: none"> • Pavement Reconstruction <p>Estimated Cost</p> <ul style="list-style-type: none"> • See above
--

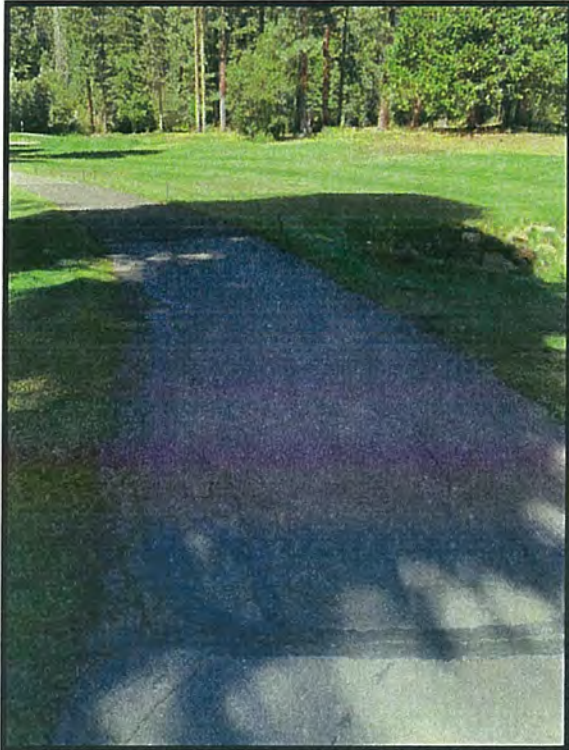
Location <ul style="list-style-type: none">• Hole 7
Pavement Distress <ul style="list-style-type: none">• Medium severity edge cracking• Medium severity transverse cracking
Ride Quality <ul style="list-style-type: none">• Very poor
Safety Concern <ul style="list-style-type: none">• Low
Length of Distress <ul style="list-style-type: none">• 50-ft
Recommended Repair <ul style="list-style-type: none">• Pavement Reconstruction
Estimated Cost <ul style="list-style-type: none">• Unit Price - \$15 / SF• 50-ft L x 8-ft W• \$6,000

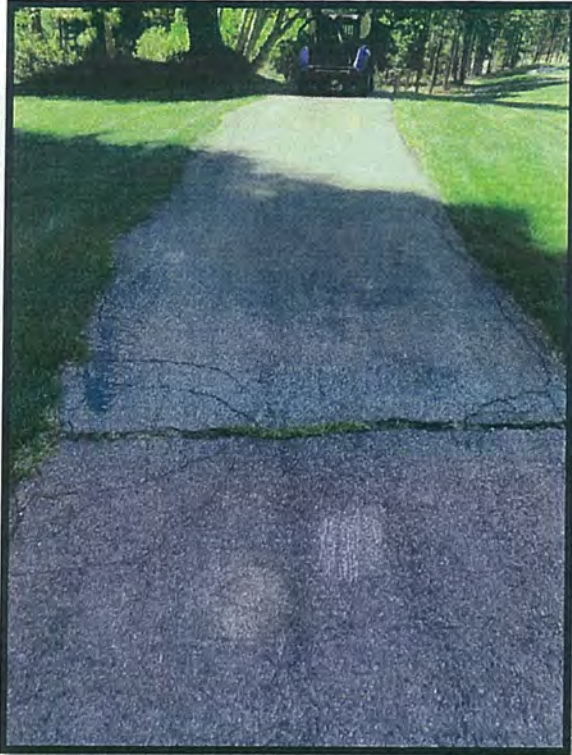
<p>Location</p> <ul style="list-style-type: none"> • Hole 13 <p>Pavement Distress</p> <ul style="list-style-type: none"> • Medium severity transverse cracking • Low severity edge cracking <p>Ride Quality</p> <ul style="list-style-type: none"> • Mediocre <p>Safety Concern</p> <ul style="list-style-type: none"> • Low <p>Length of Distress</p> <ul style="list-style-type: none"> • See above <p>Recommended Repair</p> <ul style="list-style-type: none"> • Pavement Reconstruction <p>Estimated Cost</p> <ul style="list-style-type: none"> • See above
--

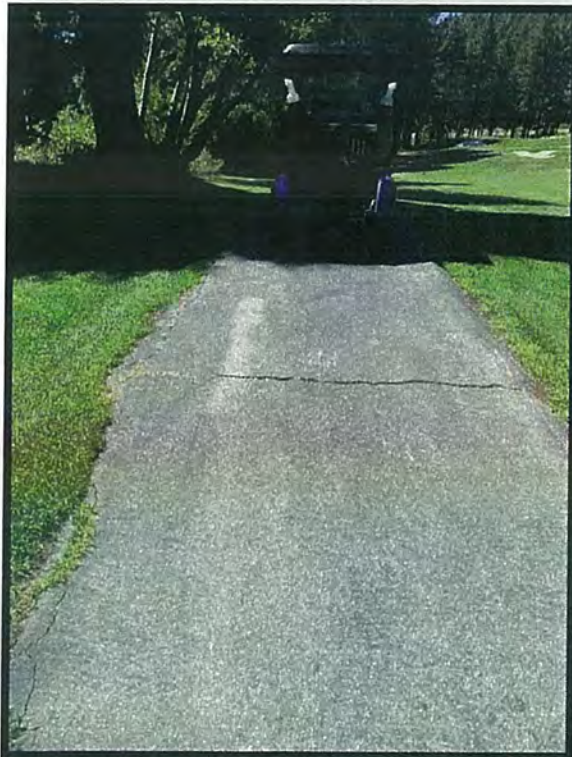
<p>Location</p> <ul style="list-style-type: none"> • Hole 13 <p>Pavement Distress</p> <ul style="list-style-type: none"> • Medium severity transverse cracking • Low severity edge cracking <p>Ride Quality</p> <ul style="list-style-type: none"> • Mediocre <p>Safety Concern</p> <ul style="list-style-type: none"> • Low <p>Length of Distress</p> <ul style="list-style-type: none"> • See above <p>Recommended Repair</p> <ul style="list-style-type: none"> • Pavement Reconstruction <p>Estimated Cost</p> <ul style="list-style-type: none"> • See above
--

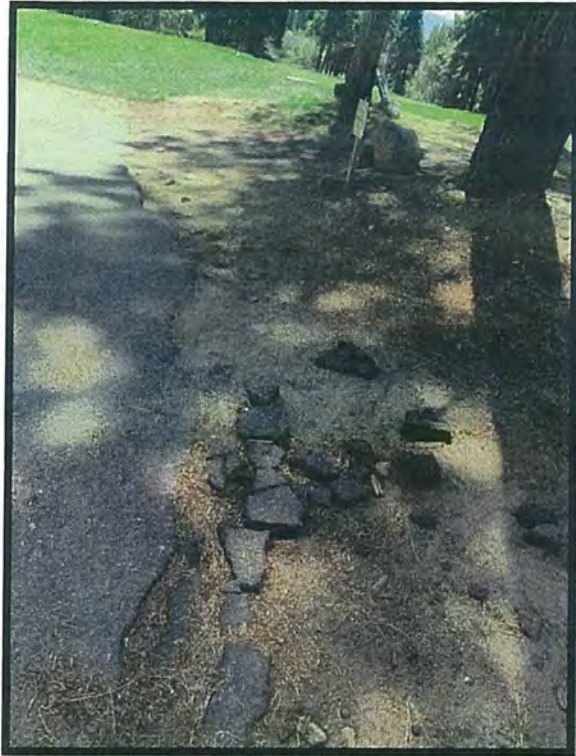
<p>Location</p> <ul style="list-style-type: none"> • Hole 16/2/3 <p>Pavement Distress</p> <ul style="list-style-type: none"> • High severity edge cracking <p>Ride Quality</p> <ul style="list-style-type: none"> • N/A <p>Safety Concern</p> <ul style="list-style-type: none"> • Low <p>Length of Distress</p> <ul style="list-style-type: none"> • 20-ft <p>Recommended Repair</p> <ul style="list-style-type: none"> • Shouldering (1-ft width, downhill side) <p>Estimated Cost</p> <ul style="list-style-type: none"> • Unit Price - \$1 / LF • 200-ft L x 1-ft W • \$200

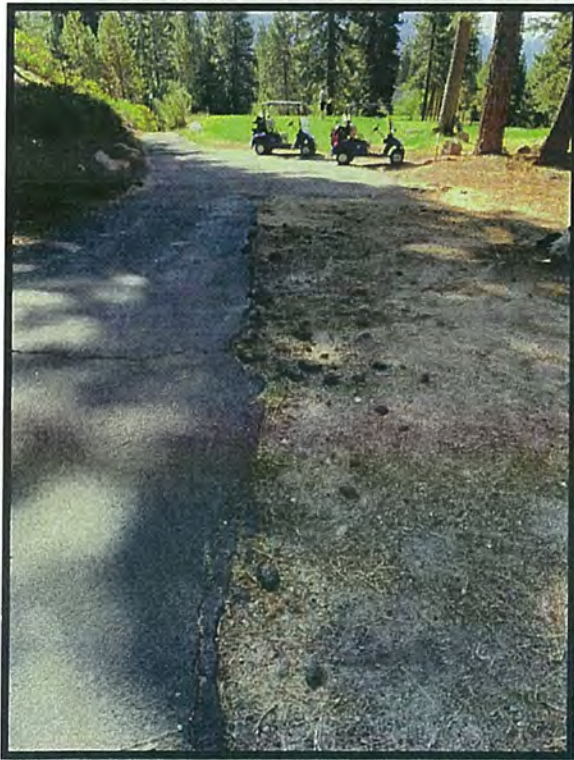
<p>Location</p> <ul style="list-style-type: none"> • Hole 16/2/3 <p>Pavement Distress</p> <ul style="list-style-type: none"> • High severity edge cracking <p>Ride Quality</p> <ul style="list-style-type: none"> • Mediocre <p>Safety Concern</p> <ul style="list-style-type: none"> • Low <p>Length of Distress</p> <ul style="list-style-type: none"> • See above <p>Recommended Repair</p> <ul style="list-style-type: none"> • Shouldering (1-ft width, downhill side) <p>Estimated Cost</p> <ul style="list-style-type: none"> • See above
--
