MEMORANDUM

SUBJECT: Review, discuss and possibly approve a design services contract for the Mountain Golf Cart Path Replacement Project – Fund: Community Services; Division: Golf; CIP# 3241LI1903; Vendor: Lumos and Associates in the amount of \$75,100

DATE: March 1, 2021

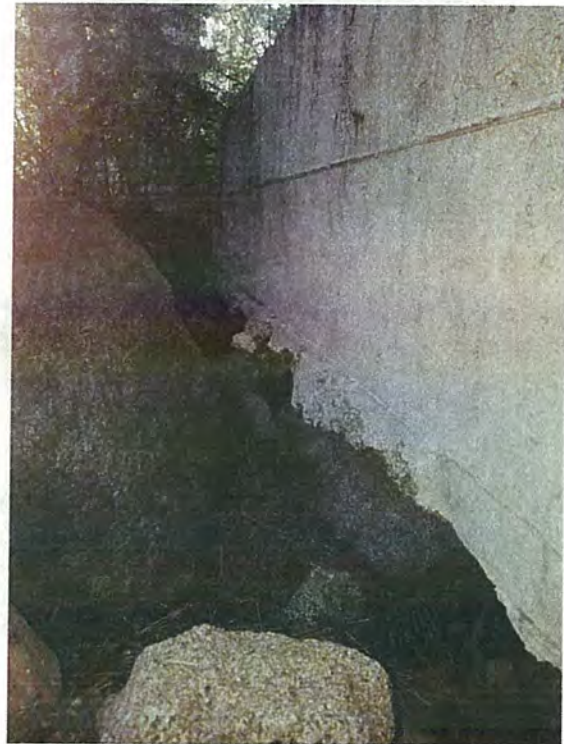
At the west abutment there is scouring beneath the abutment wall footing where the soil beneath the footing has been washed away, see Photos 3 and 4. Also at the west abutment, there is some concrete spalling at the abutment wall at the footing transition, see Photo 5. No scouring was observed at the east abutment.

Photo 4 – Scour at West Abutment Footing

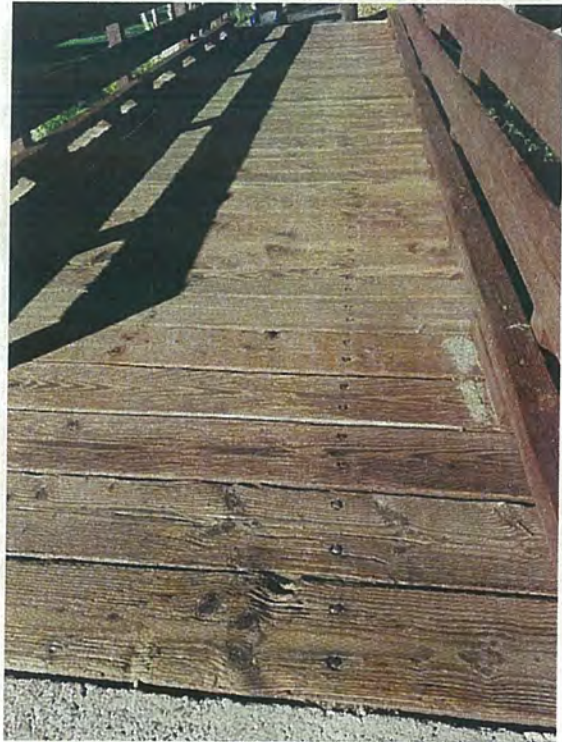
Overall, the bridge superstructure components are in good condition, see Photos 9 and 12. The planks are experiencing slight to moderate wear (Photo 10) and the glued-laminated beams are moderately weathered.

Photo 10 – Wearing at Deck Surface

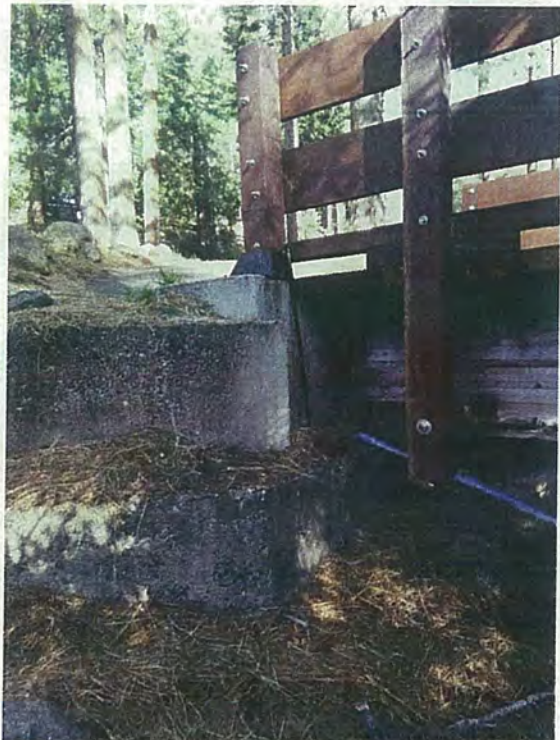
Overall, the bridge superstructure components are in good condition, see Photos 15-18. The planks are experiencing slight to moderate wear (Photo 19) and the glued-laminated beams are moderately weathered (Photo 17). The steel plate beam bearing connections at each abutment are in good condition and are experiencing only minor corrosion.

Photo 16 – View of West Abutment

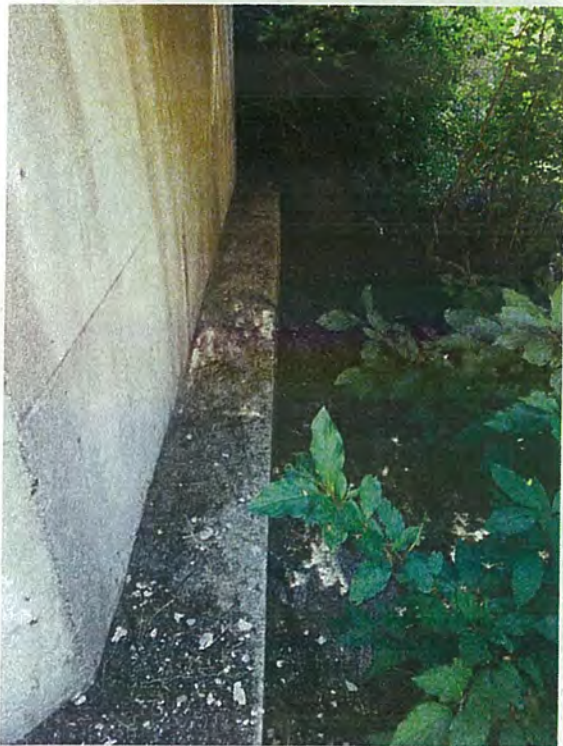
Photo 25 – View of North Abutment
