MEMORANDUM

SUBJECT: Review, discuss and possibly approve a design services contract for the Mountain Golf Cart Path Replacement Project – Fund: Community Services; Division: Golf; CIP# 3241LI1903; Vendor: Lumos and Associates in the amount of \$75,100

DATE: March 1, 2021

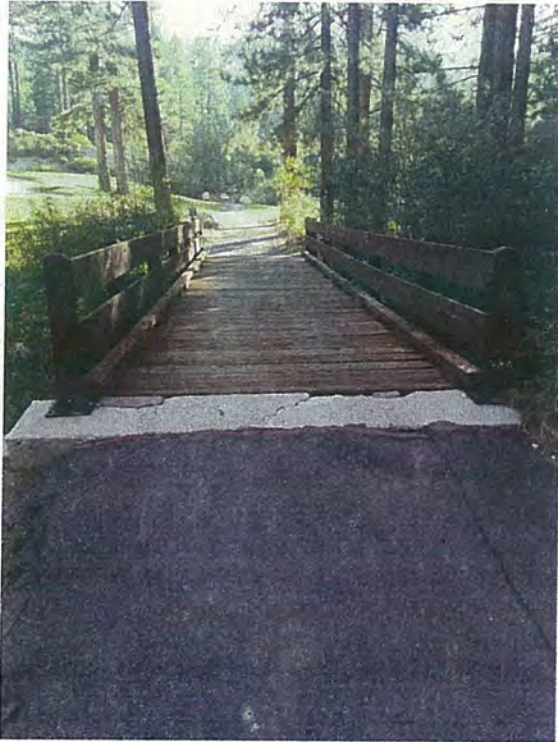
Overall, the bridge superstructure components are in good condition, see Photos 1 and 2. The planks are experiencing only slight wear and the glued-laminated beams are moderately weathered.

Photo 1 – Bridge Looking East

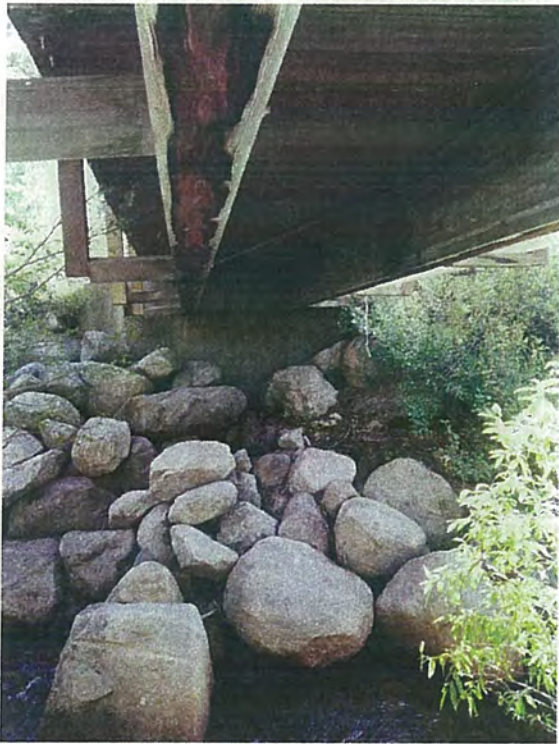
Photo 13 – View of Northeast Abutment

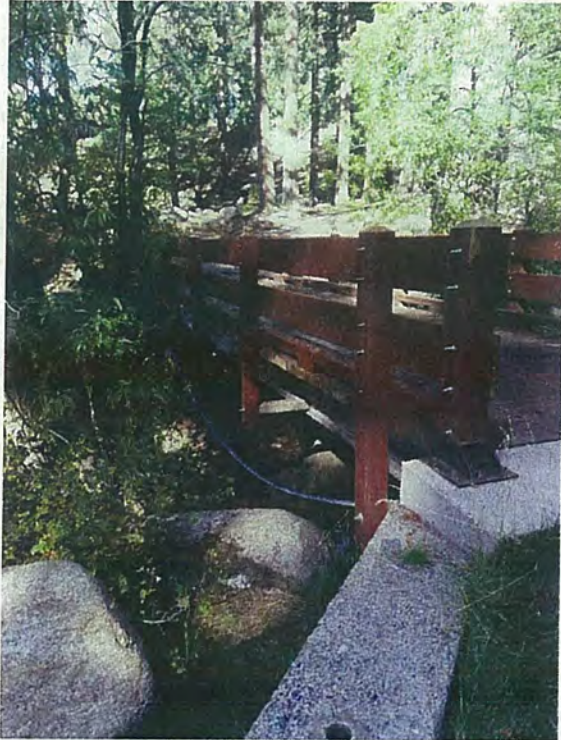
Overall, the bridge superstructure components are in good condition, see Photos 15-18. The planks are experiencing slight to moderate wear (Photo 19) and the glued-laminated beams are moderately weathered (Photo 17). The steel plate beam bearing connections at each abutment are in good condition and are experiencing only minor corrosion.

Photo 15 – View Looking West

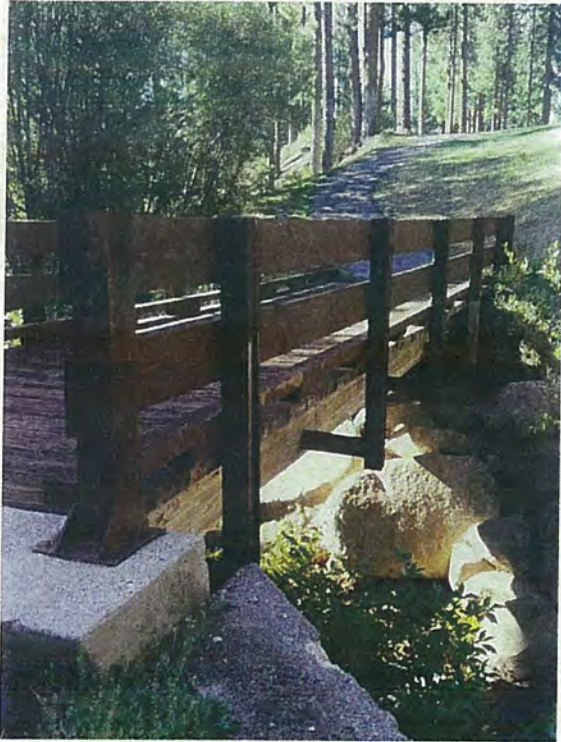
Overall, the bridge superstructure components are in good condition, see Photo 23. The planks are experiencing moderate wear (Photo 27) and the glued-laminated beams are moderately weathered (Photos 28 and 29).

Photo 23 – View Looking South

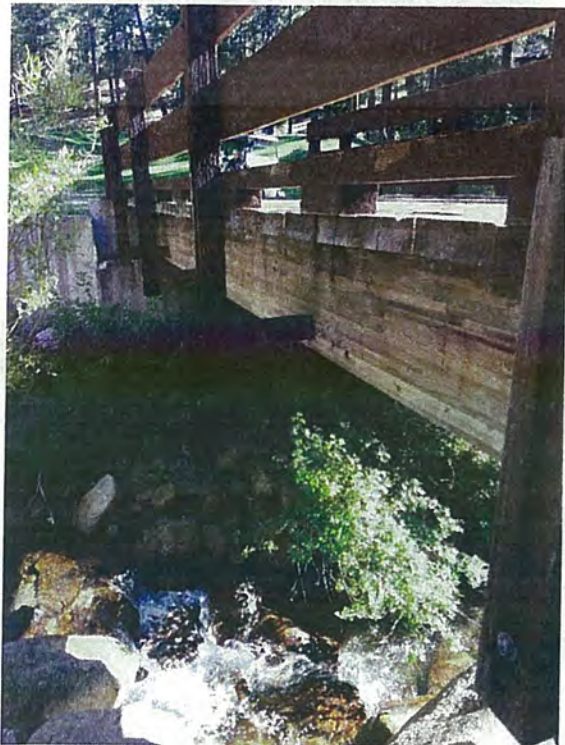
Photo 29 – Typical Weathering at Beams

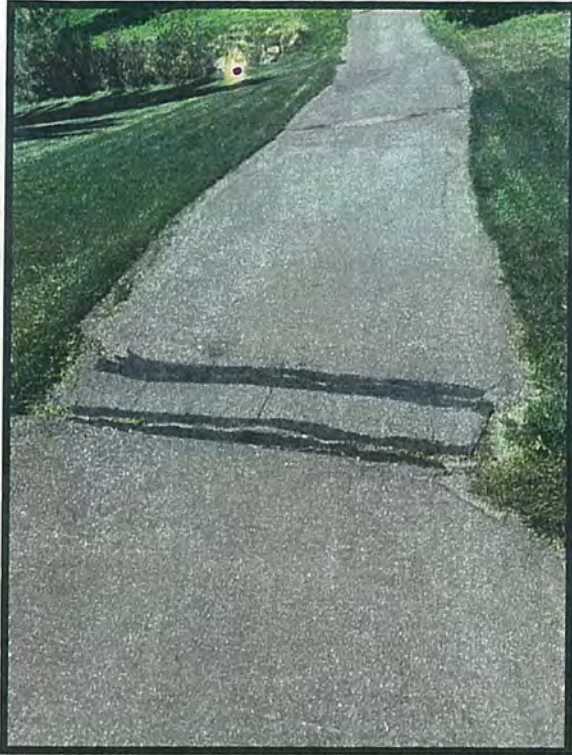
- Hole 1

- Unit Price - \$15 / SF
- 3-ft L x 8-ft W
- \$360

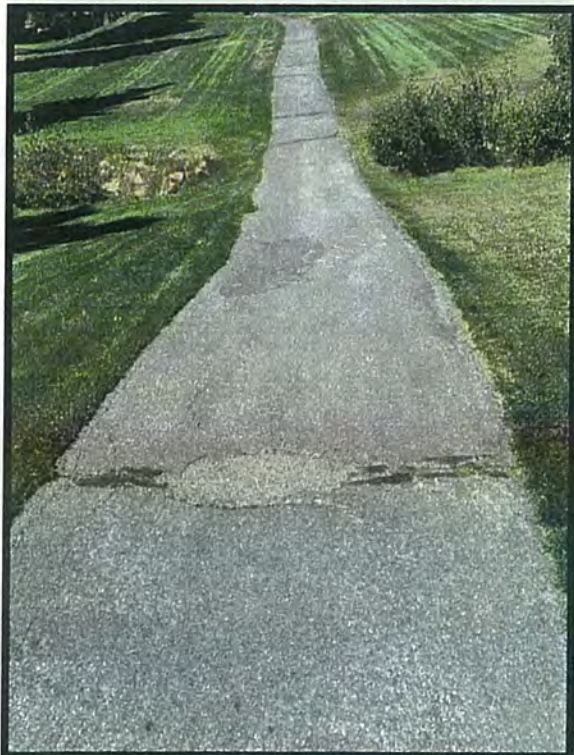
- Hole 1

- Unit Price - \$15 / SF
- 20-ft L x 8-ft W
- \$2,400

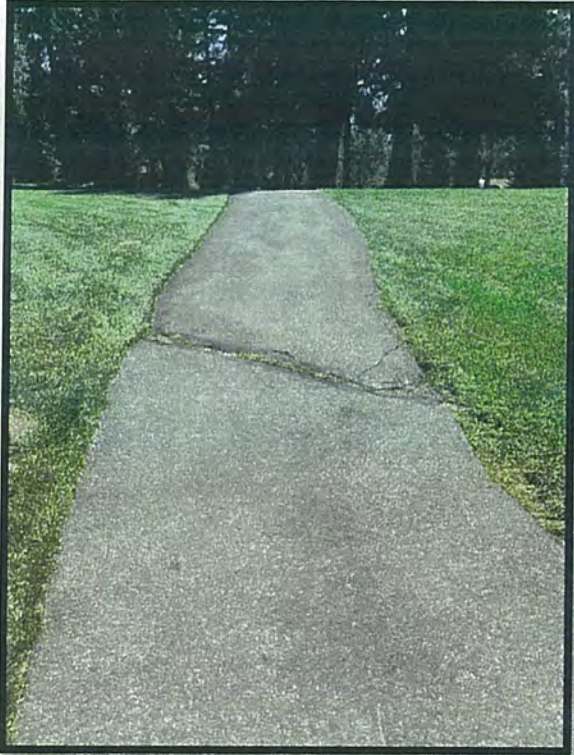
- Hole 1

- Unit Price - \$15 / SF
- 5-ft L x 8-ft W
- \$600

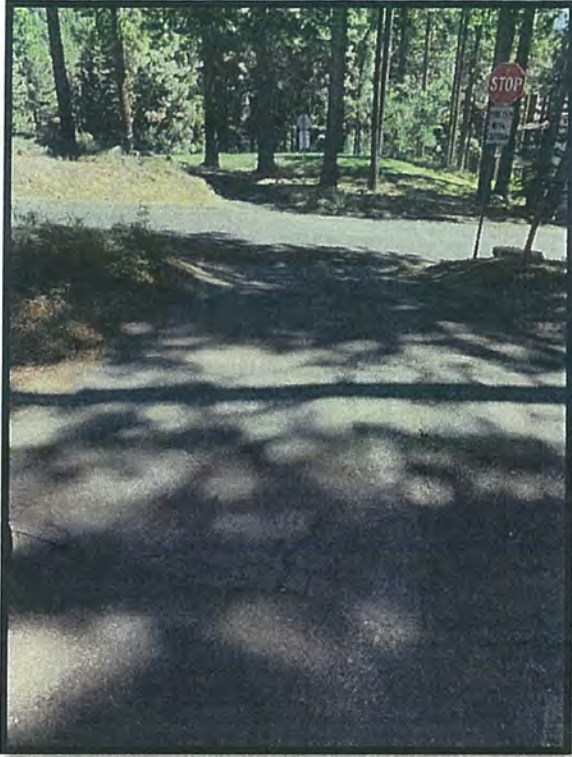
- Intersection with Golfers Pass Rd (Hole 1 to Hole 2)

- Unit Price - \$15 / SF
- 20-ft L x 15-ft W
- \$4,500

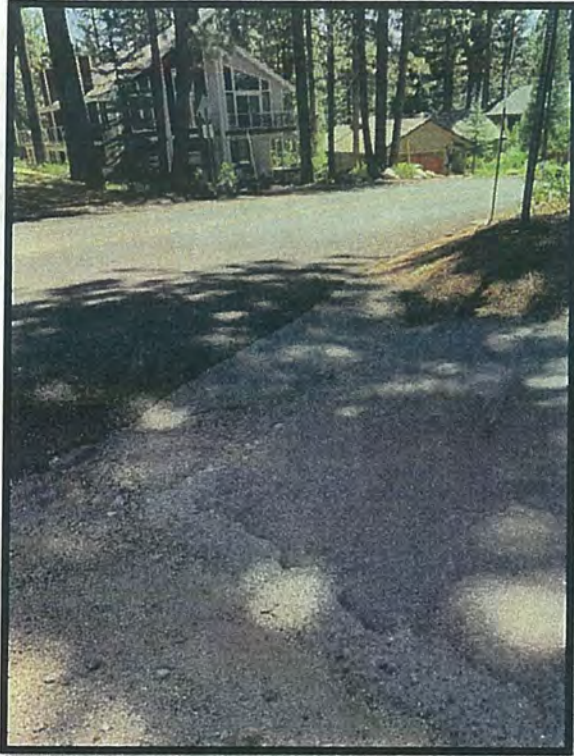
- Intersection with Golfers Pass Rd (Hole 1 to Hole 2)

- Unit Price - \$15 / SF
- 5-ft L x 10-ft W
- \$750

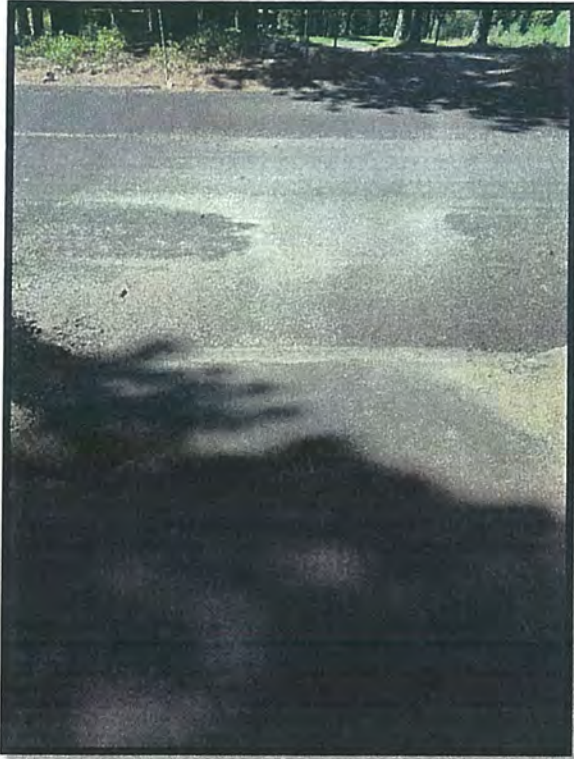
- Intersection with Golfers Pass Rd (Hole 1 to Hole 2)

- Unit Price - \$15 / SF
- 5-ft L x 8-ft W
- \$600

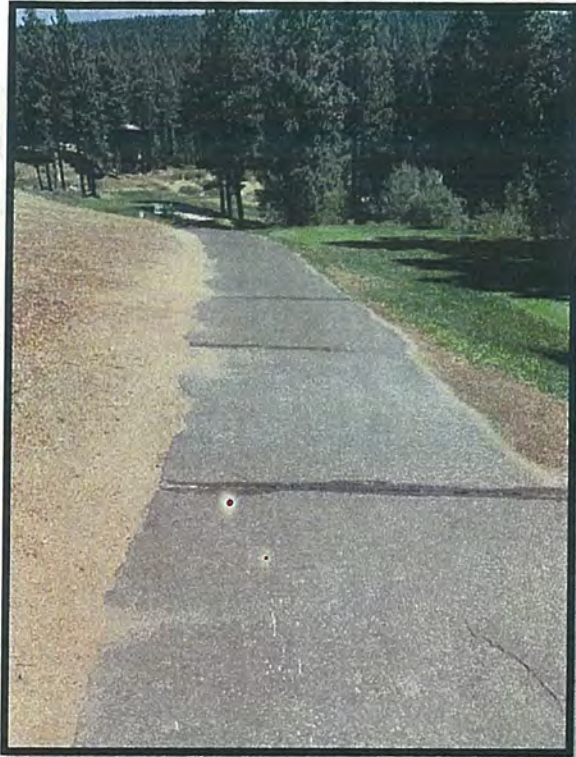
- Hole 2 Tee

- Medium severity transverse cracking
- Low severity edge cracking

Recommended Repair

- Unit Price - \$15 / SF
- 100-ft L x 8-ft W
- \$12,000

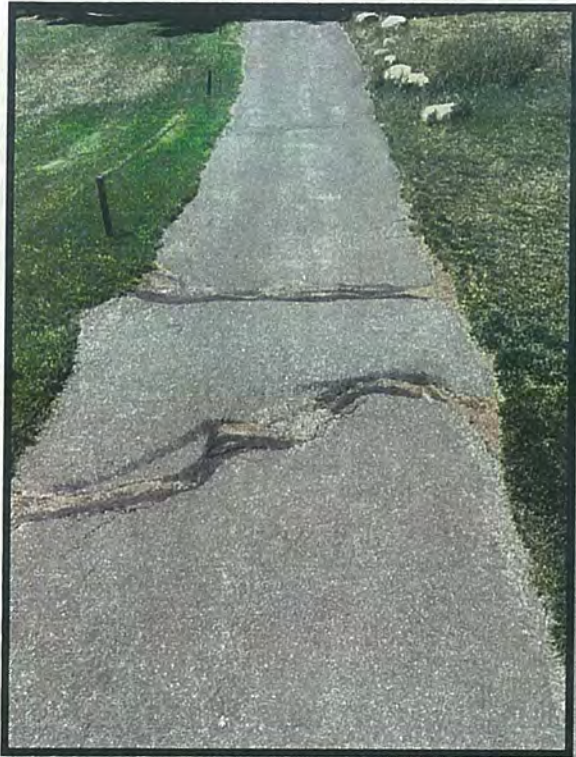
- Hole 2/3

- High severity transverse cracking

Recommended Repair

- Unit Price - \$15 / SF
- 25-ft L x 8-ft W
- \$3,000

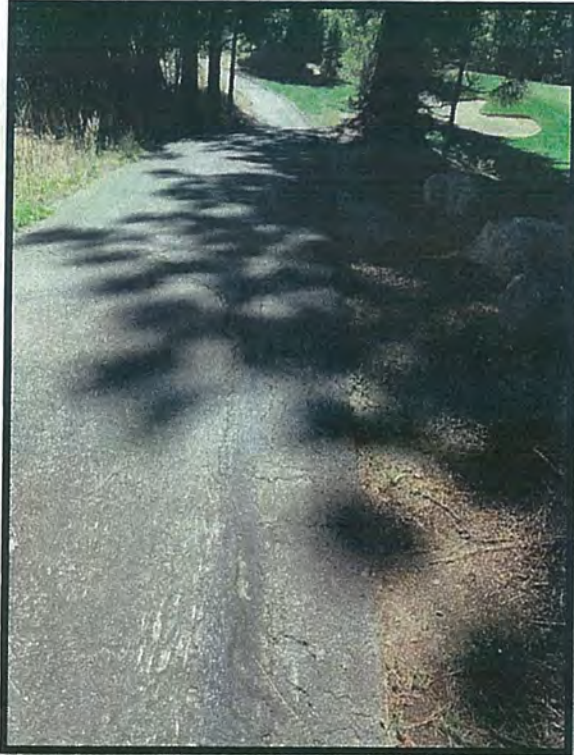
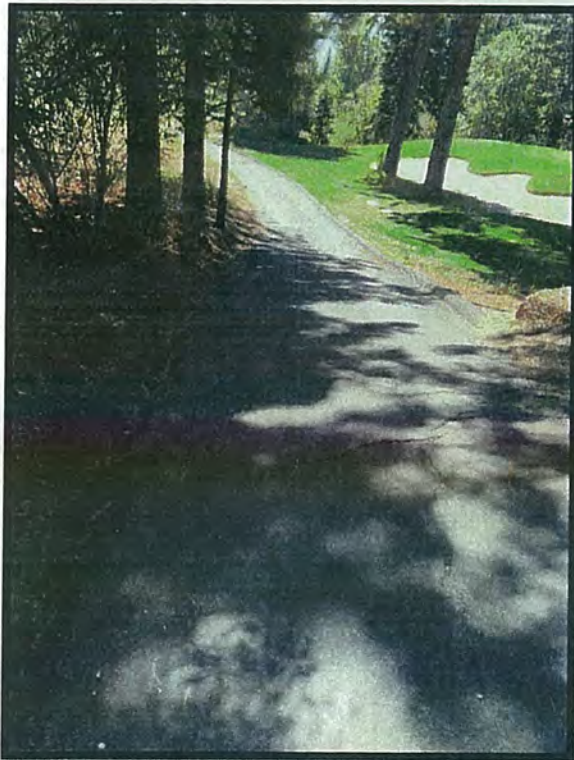
- Hole 3

- Medium severity fatigue cracking
- Medium severity transverse cracking
- Medium severity longitudinal cracking
- Medium severity edge cracking

Recommended Repair

- Unit Price - \$15 / SF (Reconstruction)
- Unit Price - \$1 / LF (Shouldering)
- 50-ft L x 8-ft W, 50-ft L x 1-ft W
- \$6,000 + \$50 = \$6,050

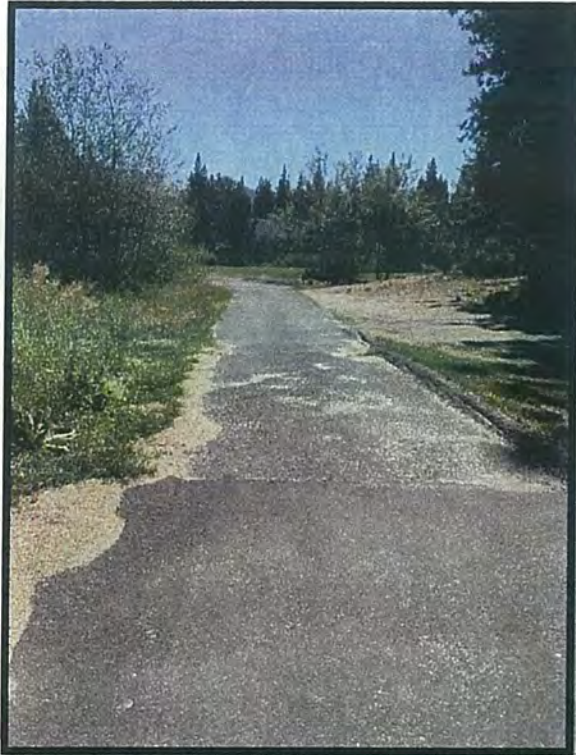
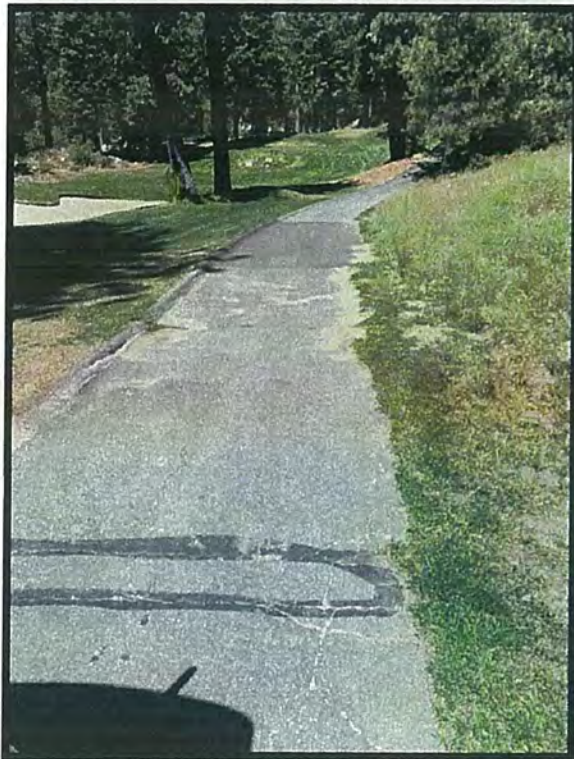
- Hole 3

- High severity transverse cracking
- Medium severity raveling

Recommended Repair

- Unit Price - \$15 / SF
- 160-ft L x 8-ft W
- \$19,200

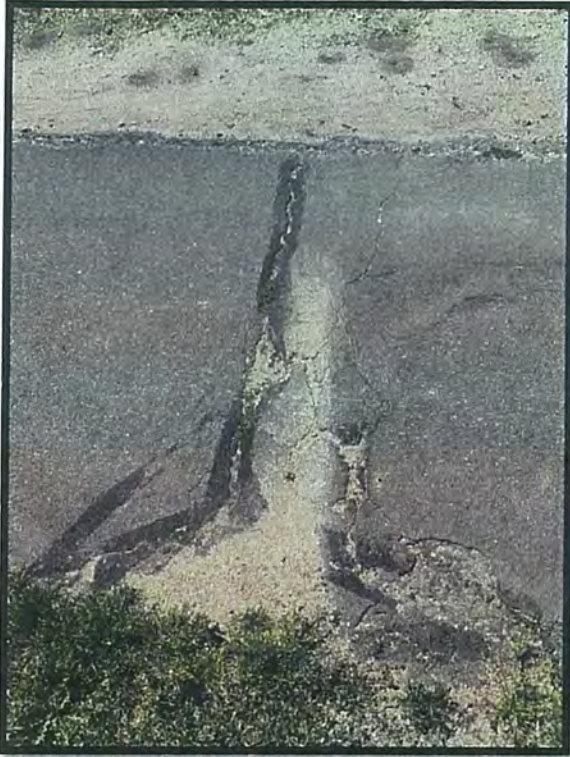
- Hole 3

- High severity transverse cracking
- High severity edge cracking

Recommended Repair

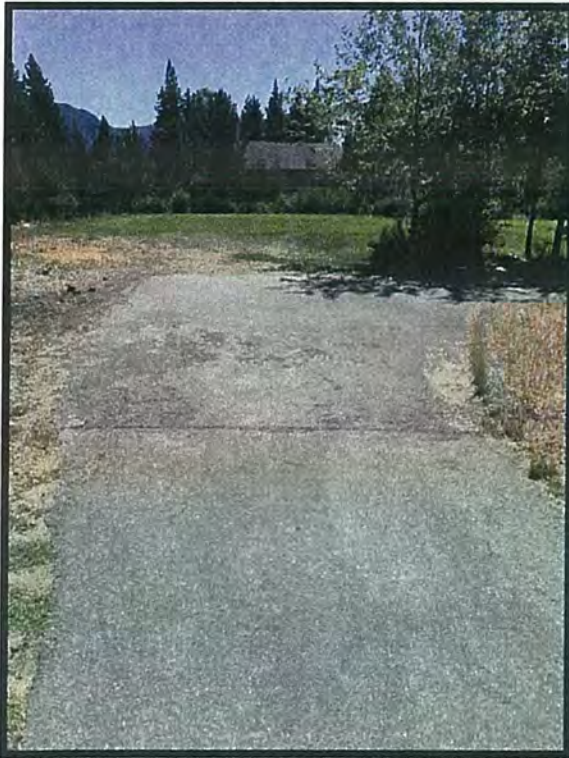
- Hole 3/4

- Medium severity transverse cracking

Recommended Repair

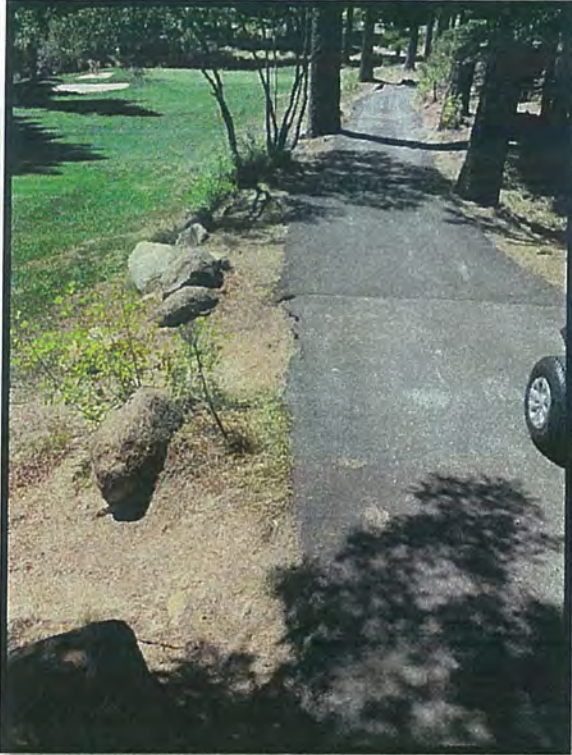
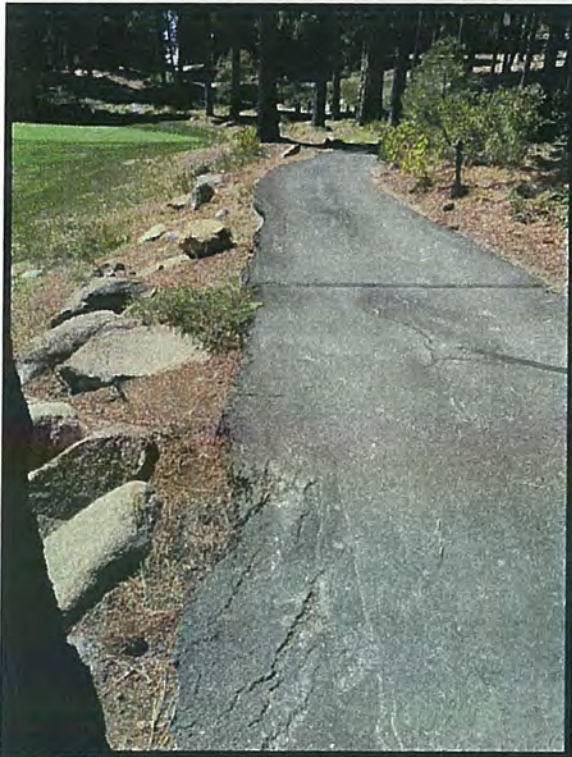
- Hole 4

- High severity edge cracking
- Medium severity transverse cracking

Recommended Repair

- Unit Price - \$15 / SF (Reconstruction)
- Unit Price - \$1 / LF (Shouldering)
- 425-ft L x 8-ft W, 850-ft L x 1-ft W
- \$51,000 + \$850 = \$51,850

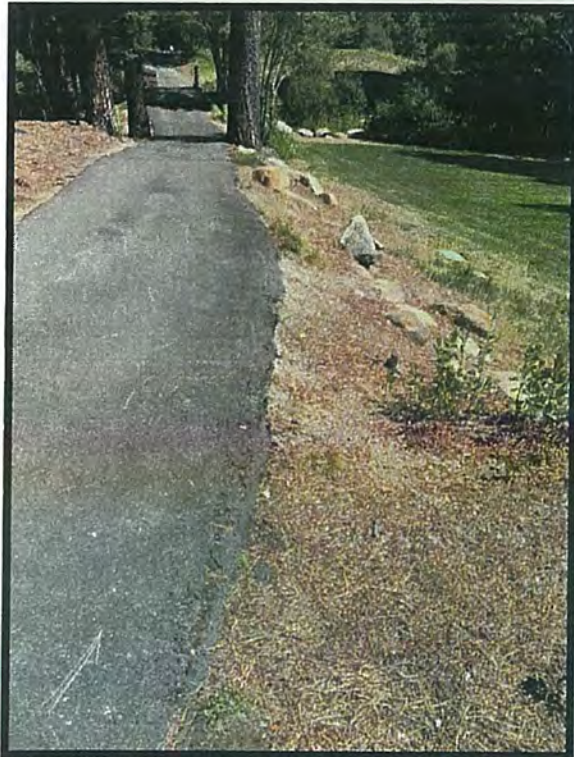
- Hole 4

- Medium severity edge cracking

Recommended Repair

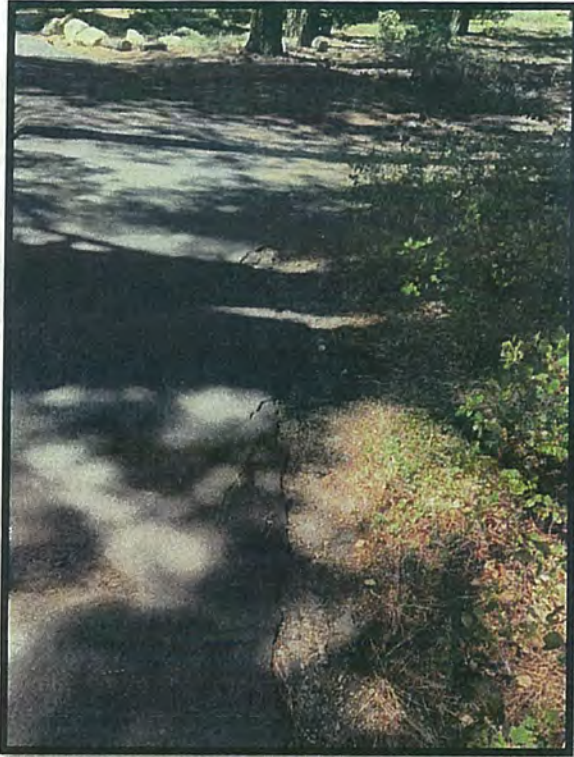
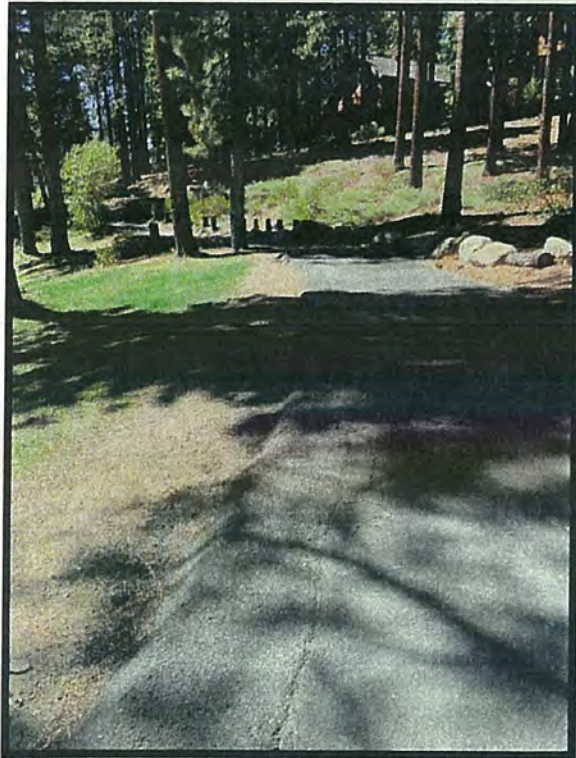
- Hole 4

- Medium severity edge cracking

Recommended Repair

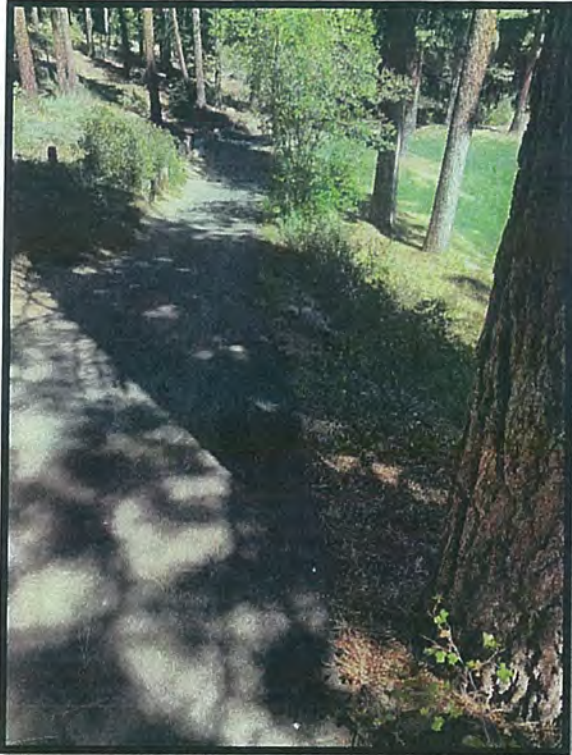
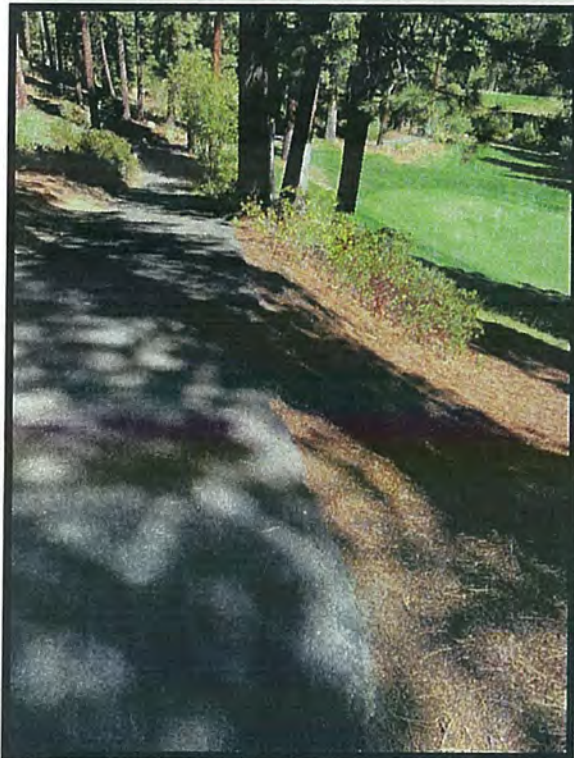
- Hole 4

- Medium severity edge cracking

Recommended Repair

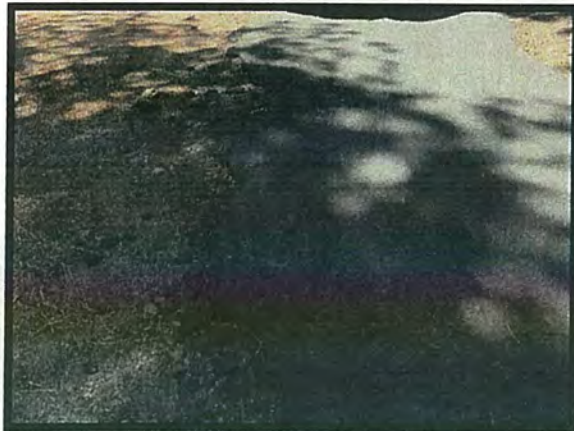
- Hole 4/5

- High severity edge cracking
- High severity fatigue cracking
- Medium severity transverse cracking

Recommended Repair

- Unit Price - \$15 / SF (Reconstruction)
- Unit Price - \$1 / LF (Shouldering)
- 25-ft L x 8-ft W, 50-ft L x 1-ft W
- \$3,000 + \$50 = \$3,050

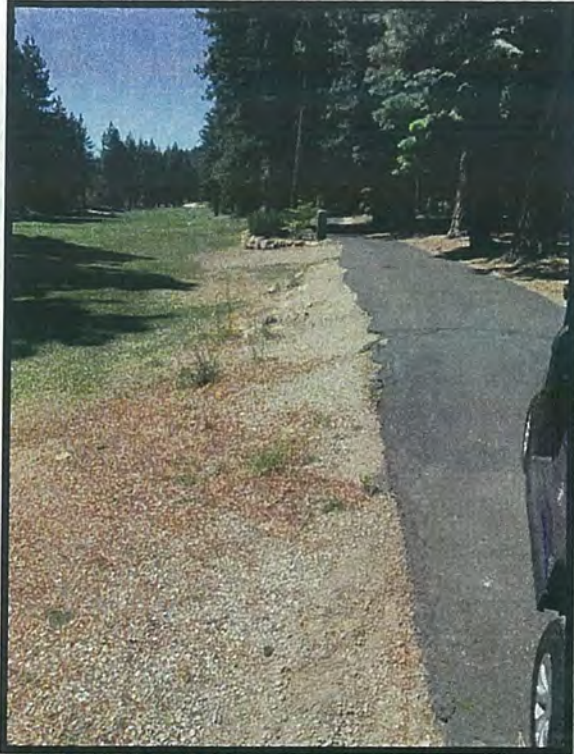
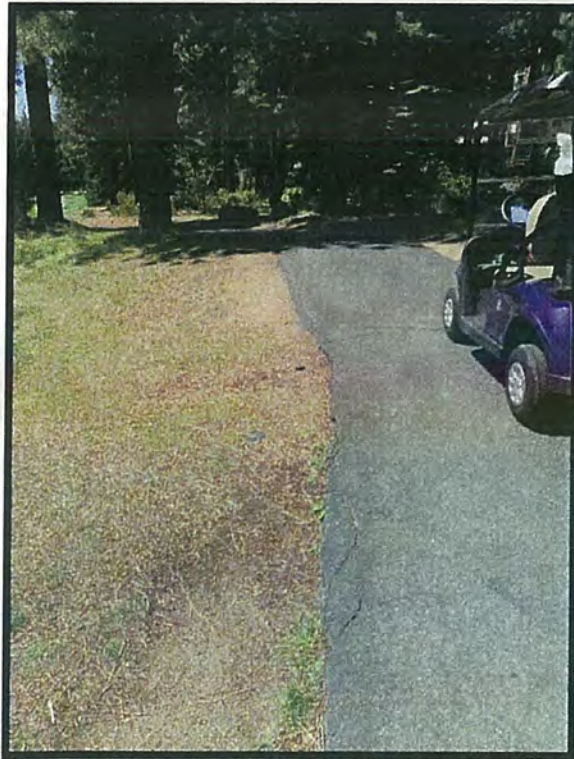
- Hole 5

- High severity edge cracking
- Medium severity transverse cracking (caused by tree roots)

Recommended Repair

- Unit Price - \$15 / SF (Reconstruction)
- Unit Price - \$1 / LF (Shouldering)
- 175-ft L x 8-ft W, 350-ft L x 1-ft W
- \$21,000 + \$350 = \$21,350

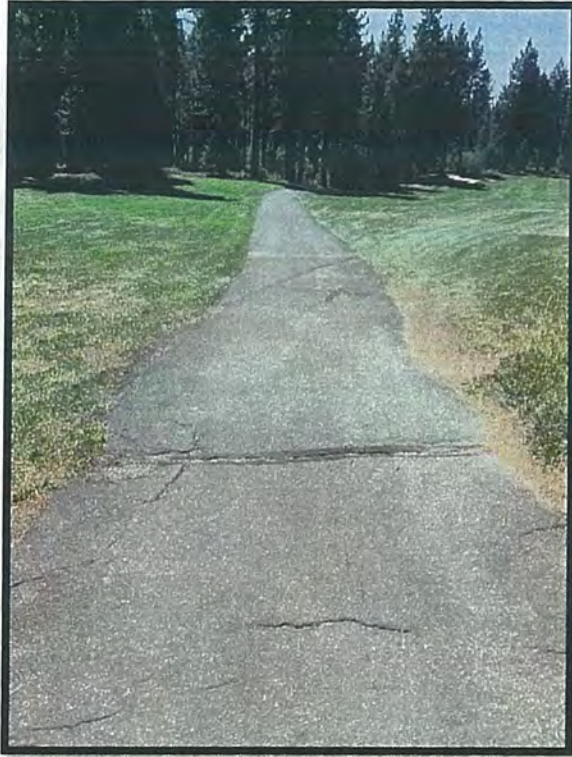
- Hole 5

- High severity transverse cracking
- Medium severity edge cracking

Recommended Repair

- Unit Price - \$15 / SF
- 25-ft L x 8-ft W
- \$3,000

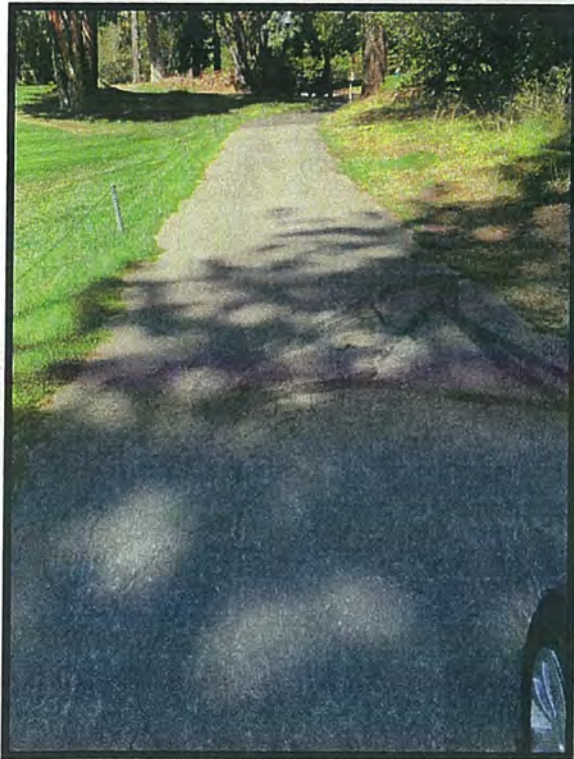
- Hole 6

- Medium severity transverse cracking
- Medium severity fatigue cracking

Recommended Repair

- Unit Price - \$15 / SF
- 25-ft L x 8-ft W
- \$3,000

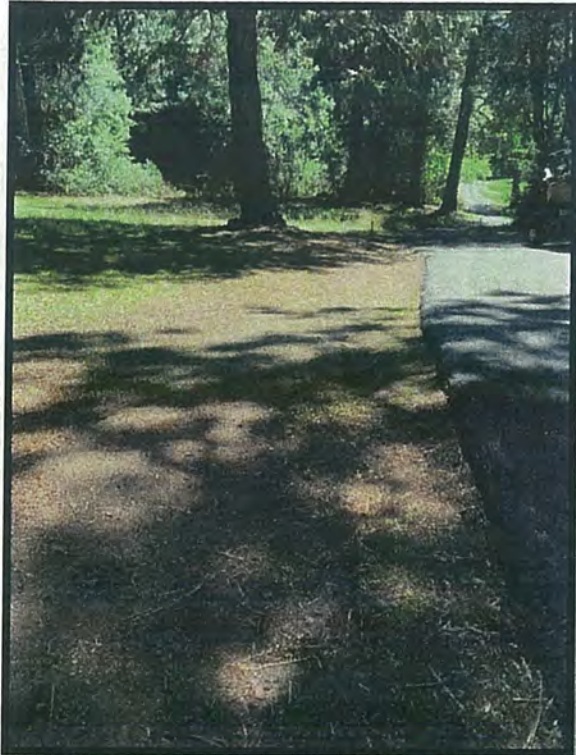
- Hole 7

- Medium severity edge cracking

Recommended Repair

- Unit Price - \$1 / LF
- 60-ft L x 1-ft W
- \$60

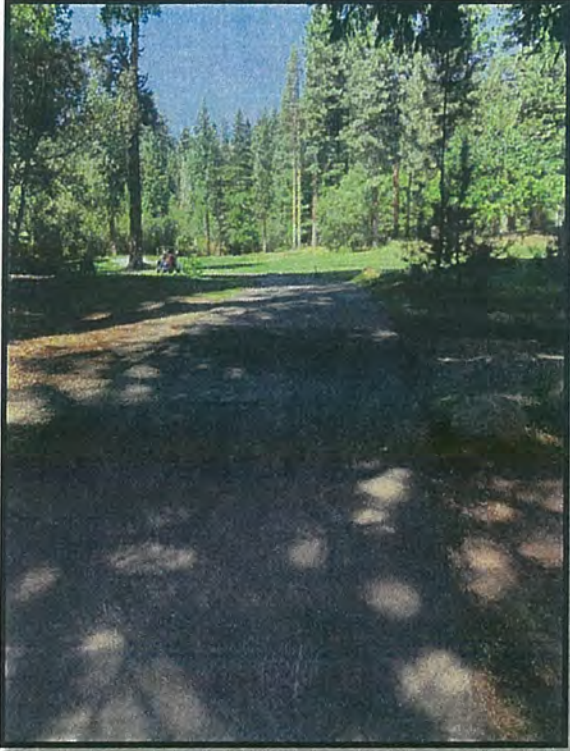
Location <ul style="list-style-type: none">• Hole 7
Pavement Distress <ul style="list-style-type: none">• Medium severity edge cracking• Medium severity transverse cracking
Ride Quality <ul style="list-style-type: none">• Very poor
Safety Concern <ul style="list-style-type: none">• Low
Length of Distress <ul style="list-style-type: none">• 50-ft
Recommended Repair <ul style="list-style-type: none">• Pavement Reconstruction
Estimated Cost <ul style="list-style-type: none">• Unit Price - \$15 / SF• 50-ft L x 8-ft W• \$6,000

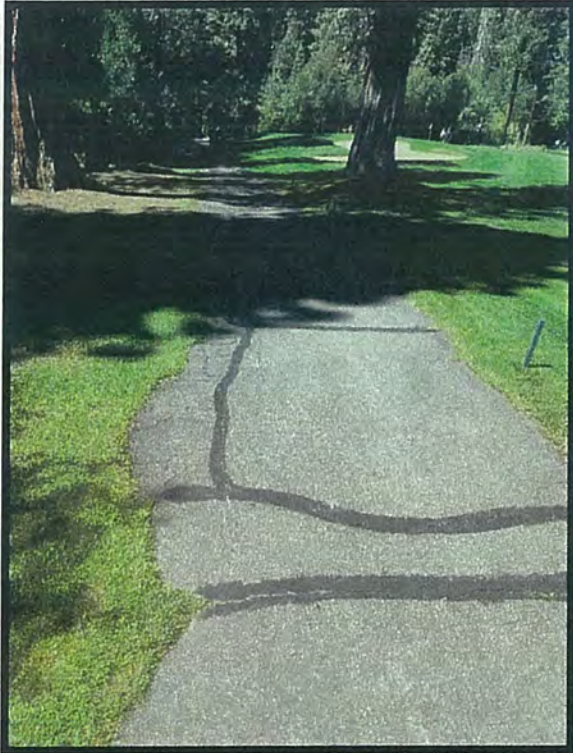
- Hole 7

- High severity fatigue cracking
- Medium severity edge cracking
- Medium severity transverse cracking

Recommended Repair

- Unit Price - \$15 / SF
- 515-ft L x 8-ft W
- \$61,200

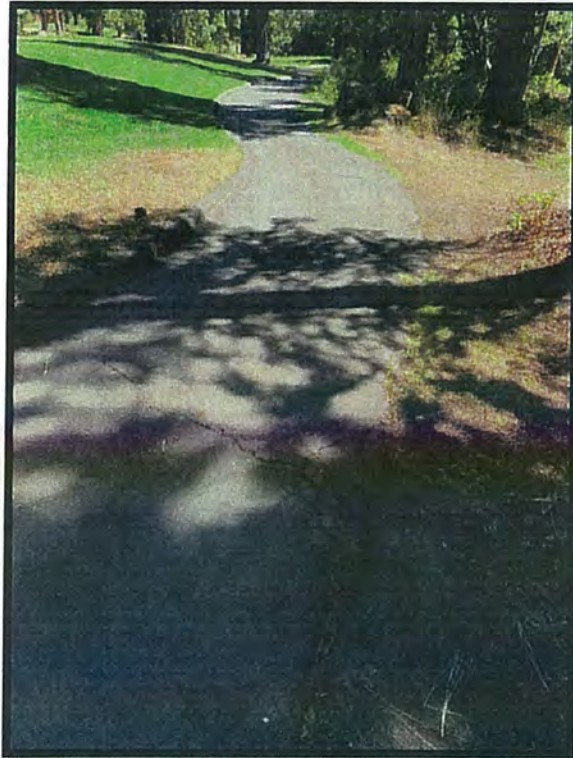
- Hole 7

- High severity edge cracking
- Medium severity transverse cracking

Recommended Repair

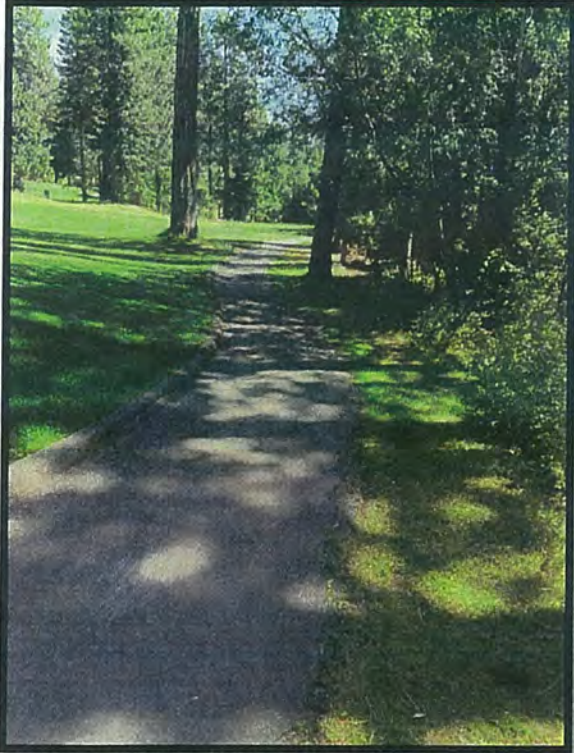
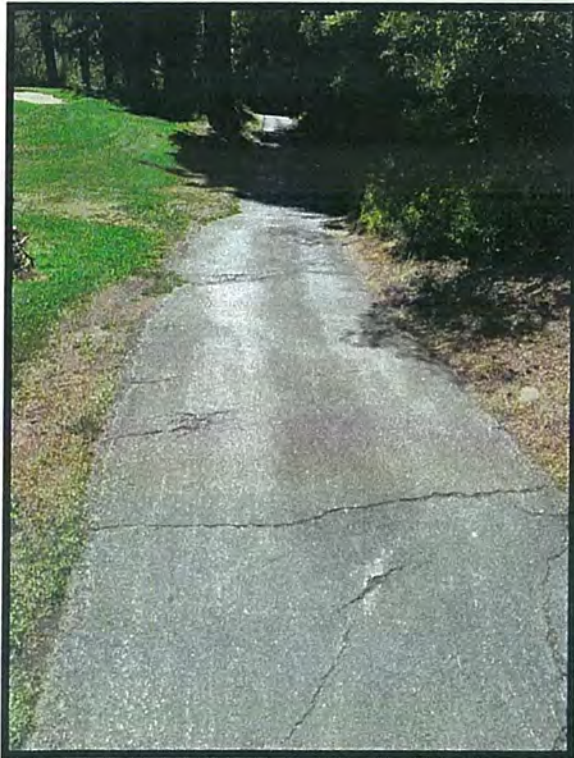
- Hole 7

- Medium severity edge cracking
- Medium severity transverse cracking

Recommended Repair

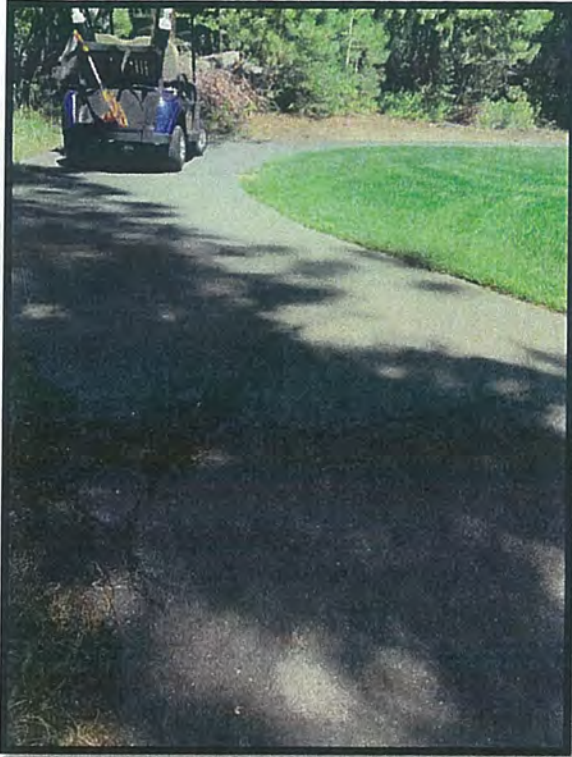
- Hole 7

- High severity transverse cracking (caused by tree roots)

Recommended Repair

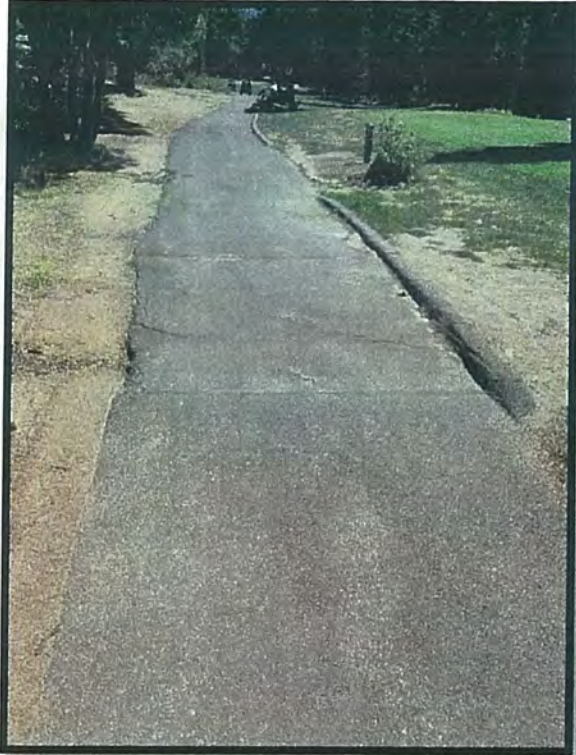
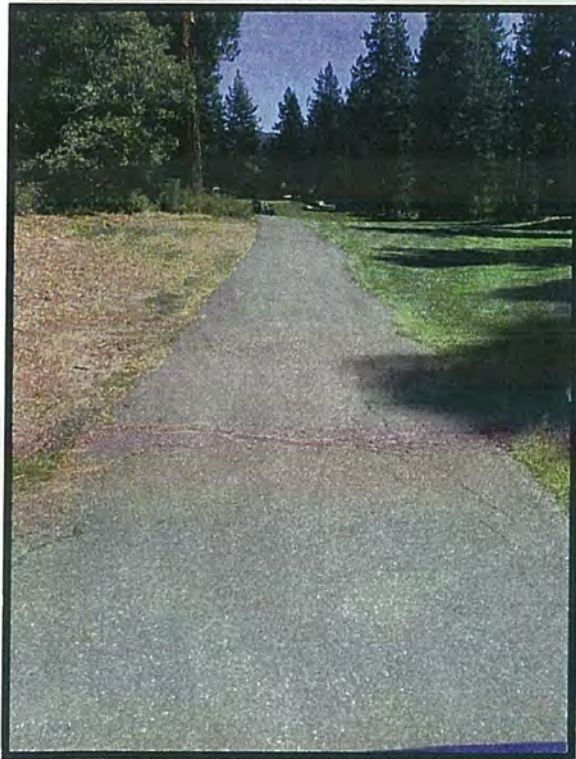
- Hole 8

- High severity transverse cracking
- Medium severity fatigue cracking
- Low severity edge cracking

Recommended Repair

- Unit Price - \$15 / SF
- 730-ft L x 8-ft W
- \$87,600

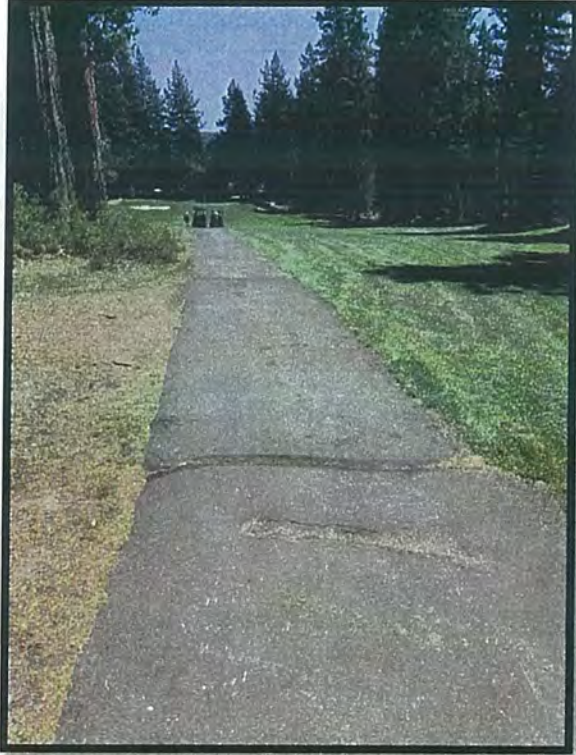
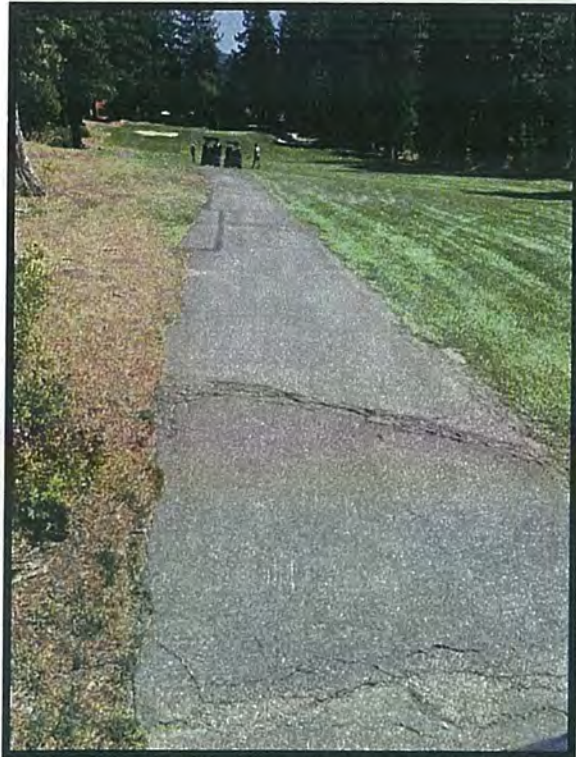
- Hole 8

- High severity transverse cracking
- High severity depression
- Medium severity raveling
- Low severity edge cracking

Recommended Repair

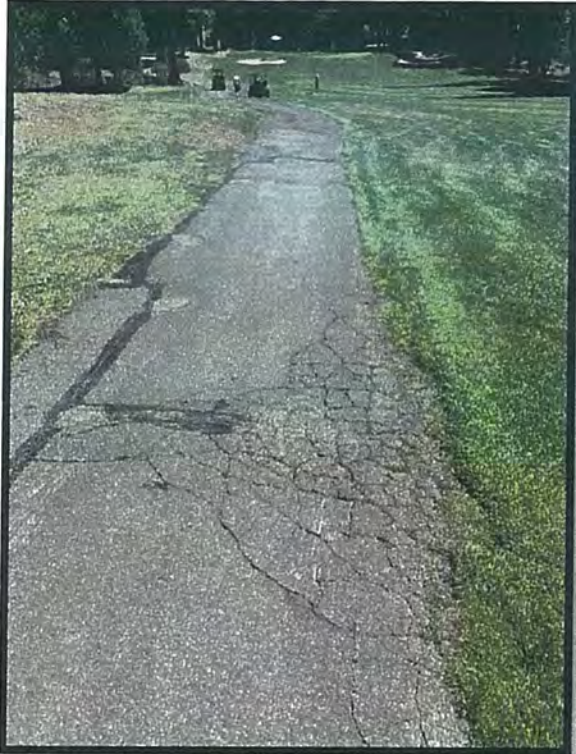
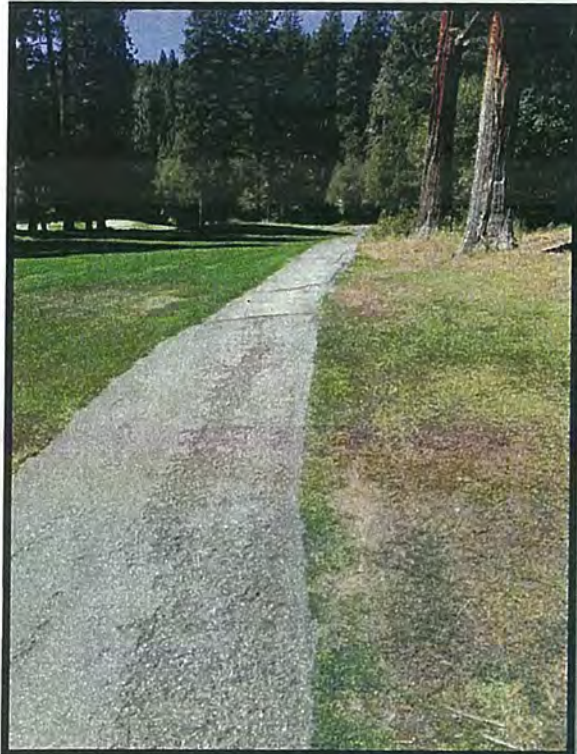
- Hole 8

- High severity raveling
- High severity transverse cracking
- High severity fatigue cracking

Recommended Repair

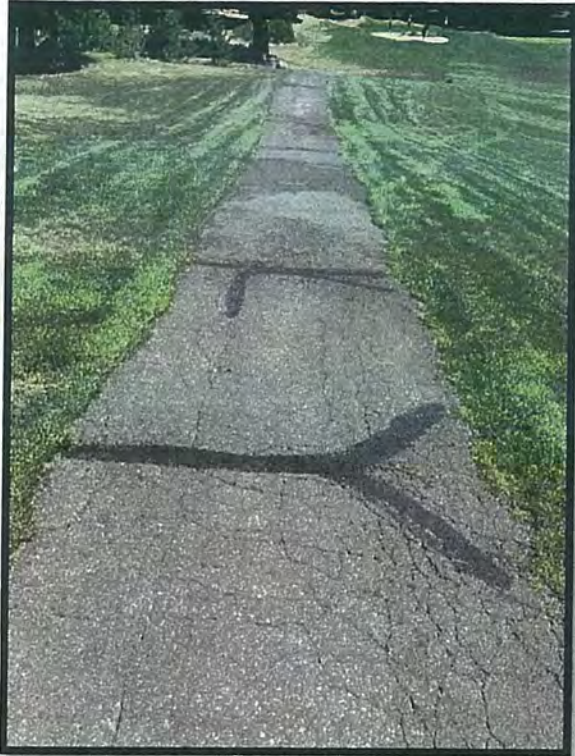
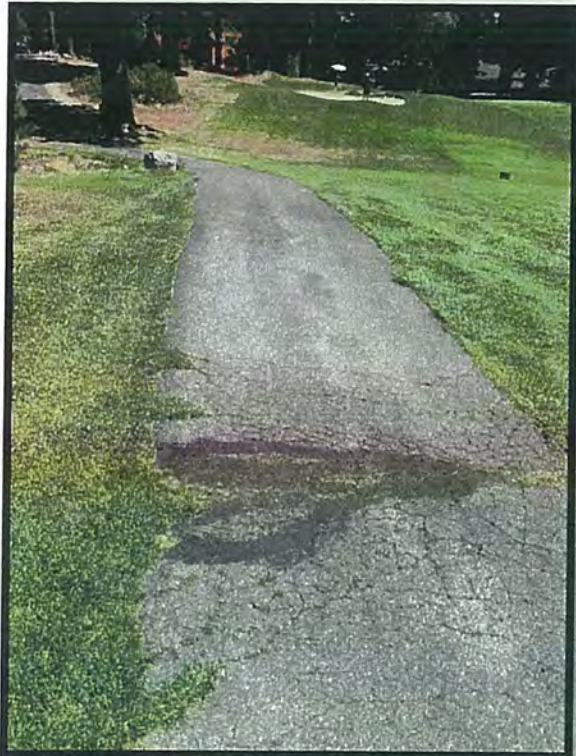
- Hole 8

- High severity transverse cracking
- Medium severity fatigue cracking
- High severity raveling

Recommended Repair

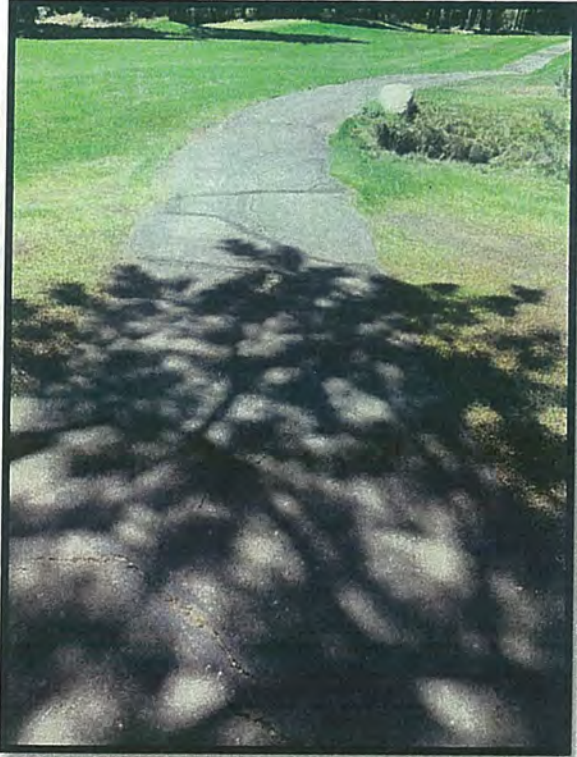
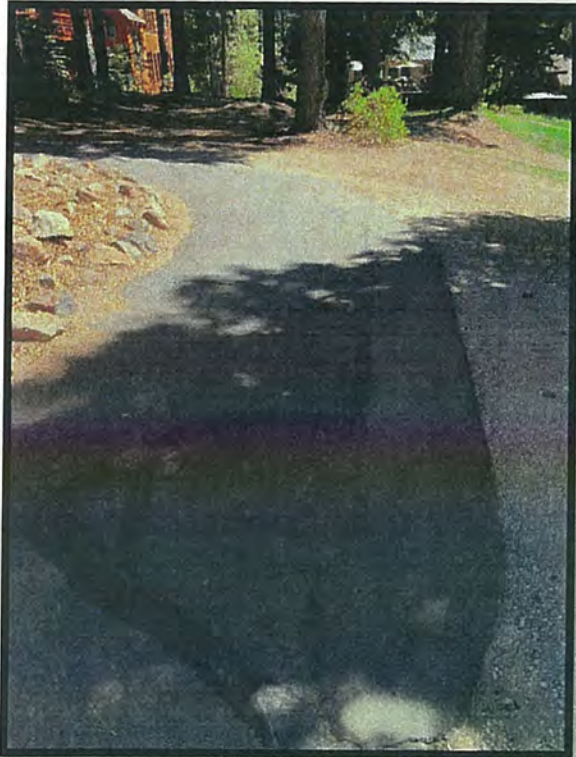
- Hole 8

- High severity transverse cracking
- Medium severity edge cracking

Recommended Repair

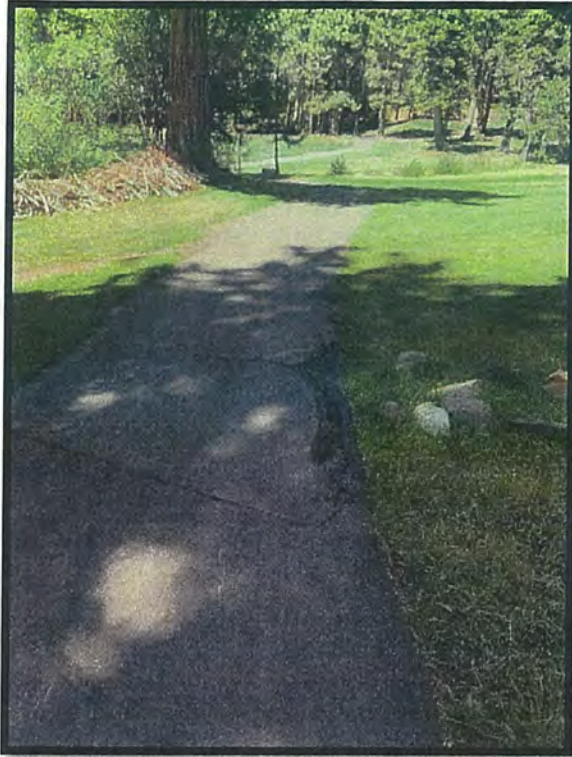
- Hole 9

- High severity edge cracking
- Medium severity transverse cracking

Recommended Repair

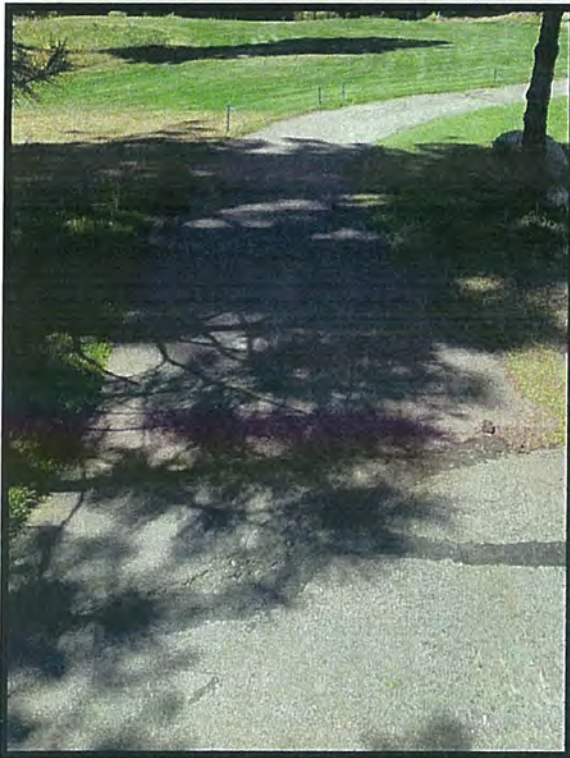
- Hole 9

- Medium severity fatigue cracking
- Medium severity transverse cracking

Recommended Repair

- Unit Price - \$15 / SF
- 175-ft L x 8-ft W
- \$21,000
