MEMORANDUM

SUBJECT: Review, discuss and possibly approve a design services contract for the Mountain Golf Cart Path Replacement Project – Fund: Community Services; Division: Golf; CIP# 3241LI1903; Vendor: Lumos and Associates in the amount of \$75,100

DATE: March 1, 2021

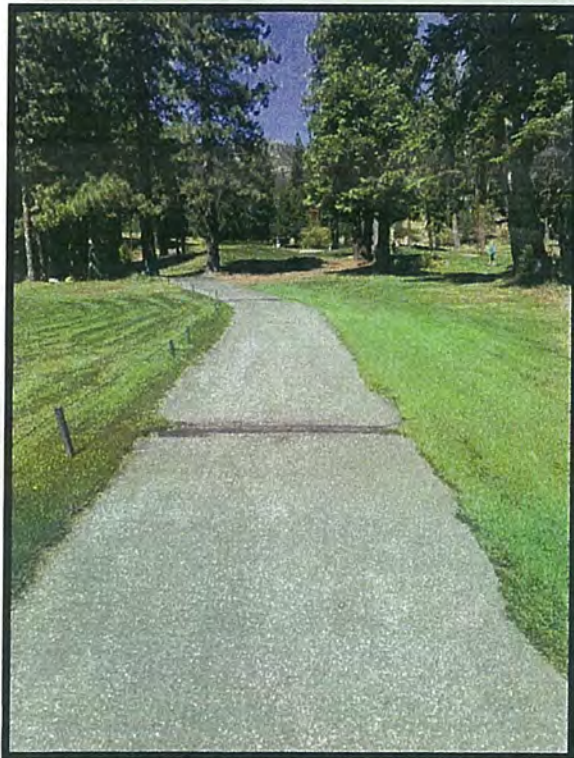
- Hole 9

- High severity transverse cracking
- Medium severity fatigue cracking

Recommended Repair

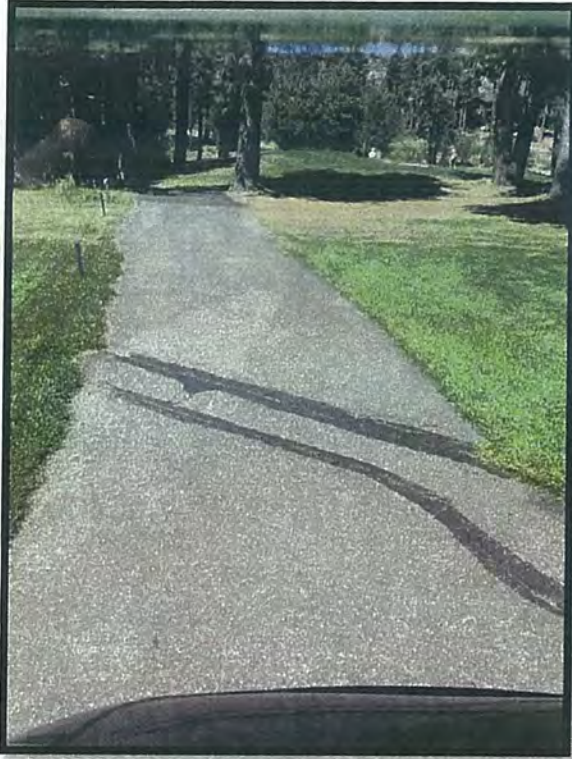
- Hole 9

- High severity transverse cracking

Recommended Repair

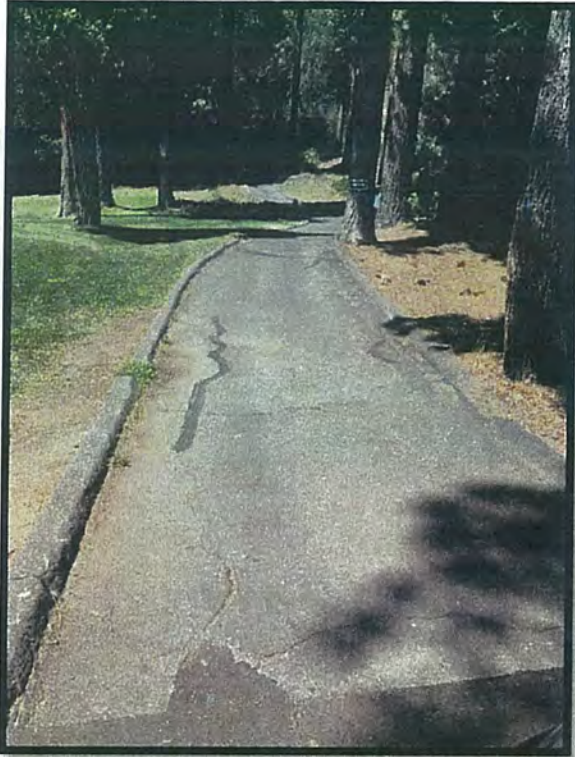
- Hole 9/18

- Medium severity transverse cracking (caused by tree roots)
- Low severity longitudinal cracking

Recommended Repair

- Unit Price - \$15 / SF
- 260-ft L x 8-ft W
- \$31,200

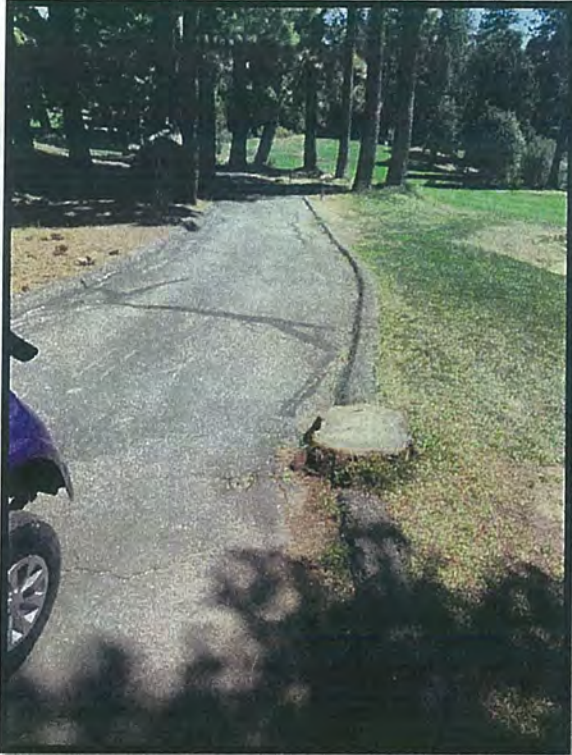
- Hole 9/18

- Medium severity transverse cracking
- Medium severity edge cracking

Recommended Repair

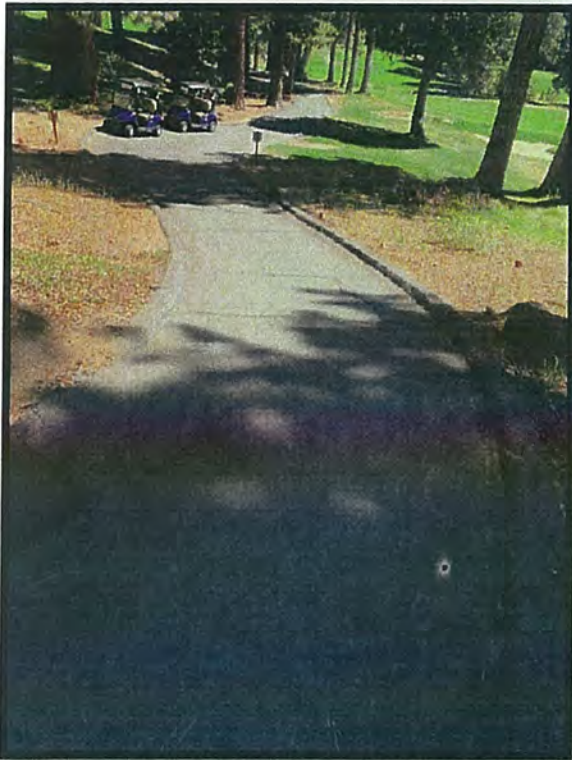
- Hole 9/18

- Medium severity transverse cracking
- Medium severity edge cracking

Recommended Repair

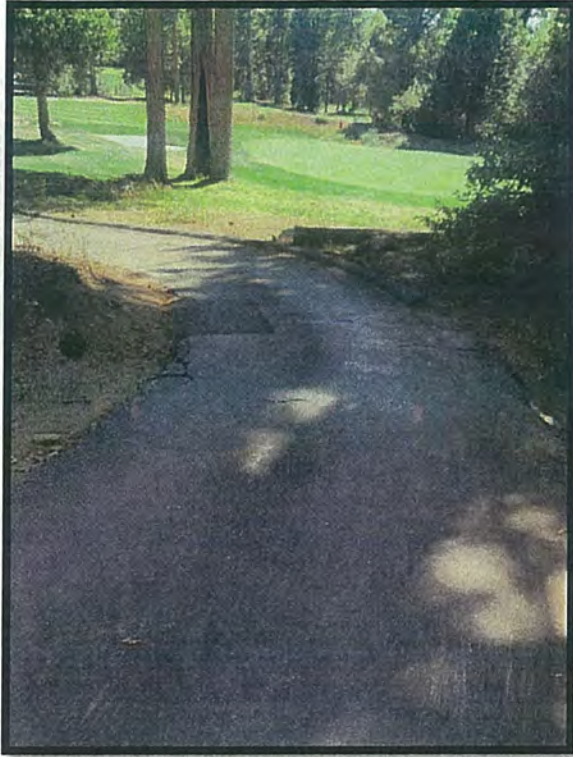
- Hole 9/18

- Medium severity edge cracking
- Low severity transverse cracking

Recommended Repair

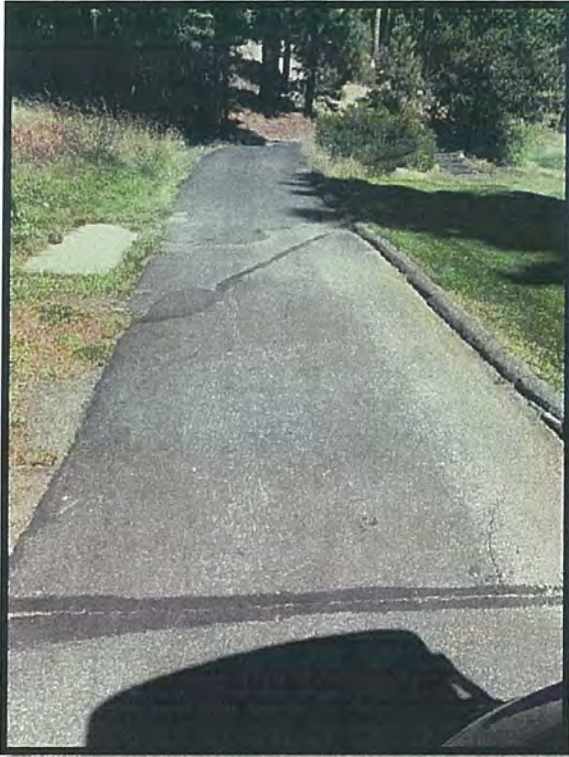
- Hole 10

- Medium severity transverse cracking

Recommended Repair

- Unit Price - \$15 / SF
- 25-ft L x 8-ft W
- \$3,000

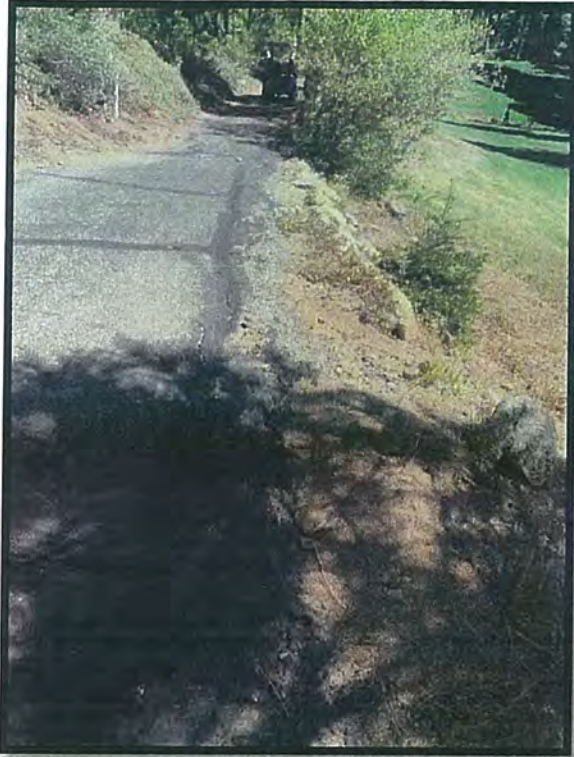
- Hole 10

- High severity edge cracking
- High severity transverse cracking
- High severity longitudinal cracking

Recommended Repair

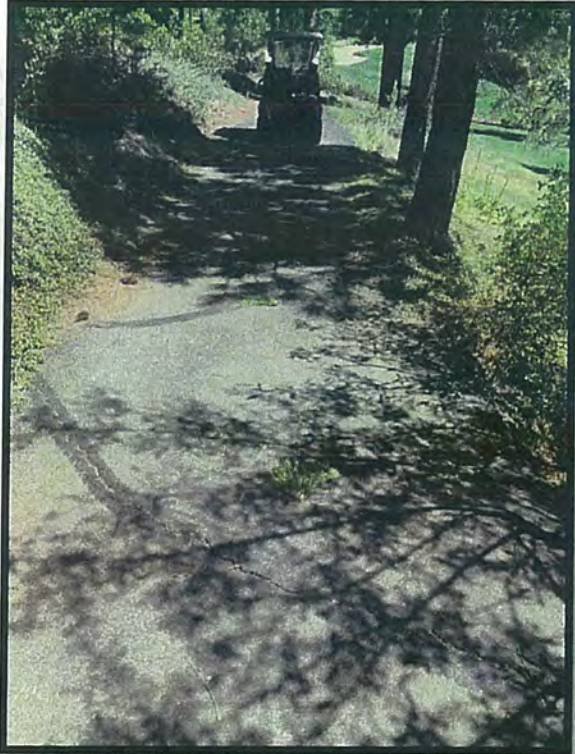
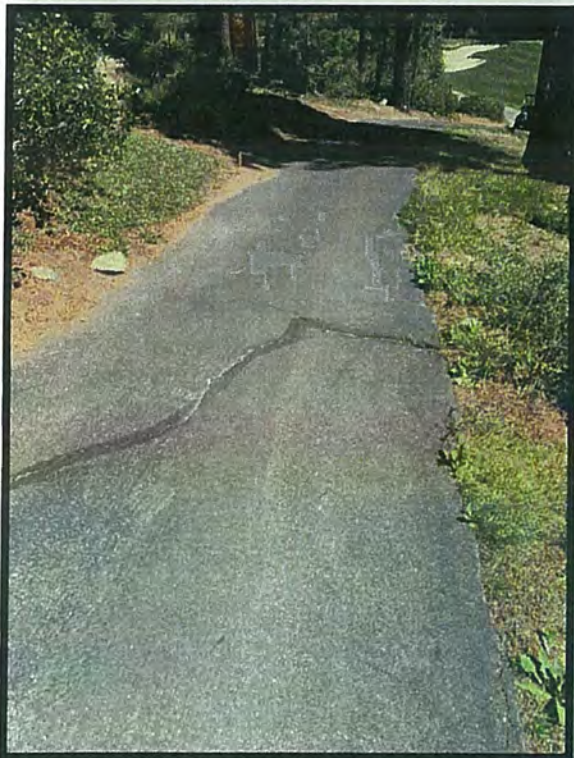
- Hole 10

- High severity edge cracking
- Medium severity transverse cracking (caused by tree roots)

Recommended Repair

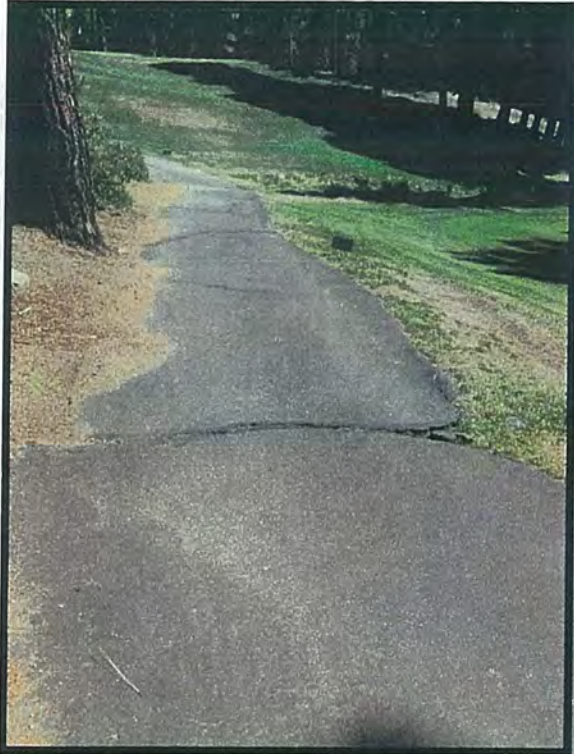
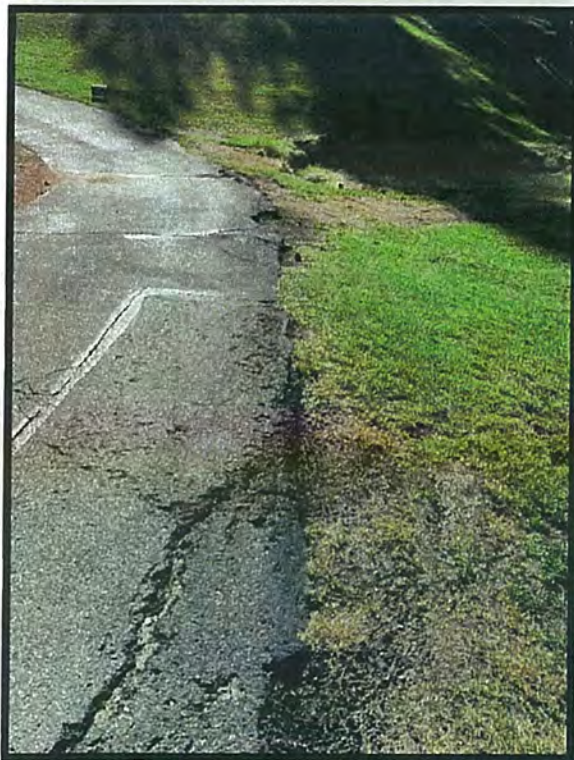
- Hole 10

- High severity transverse cracking
- High severity edge cracking
- Medium severity raveling

Recommended Repair

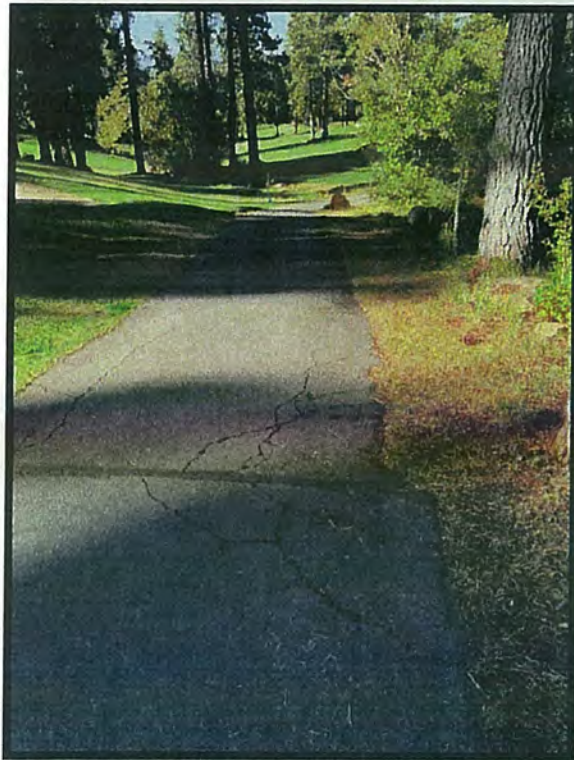
- Hole 10

- High severity edge cracking
- High severity transverse cracking

Recommended Repair

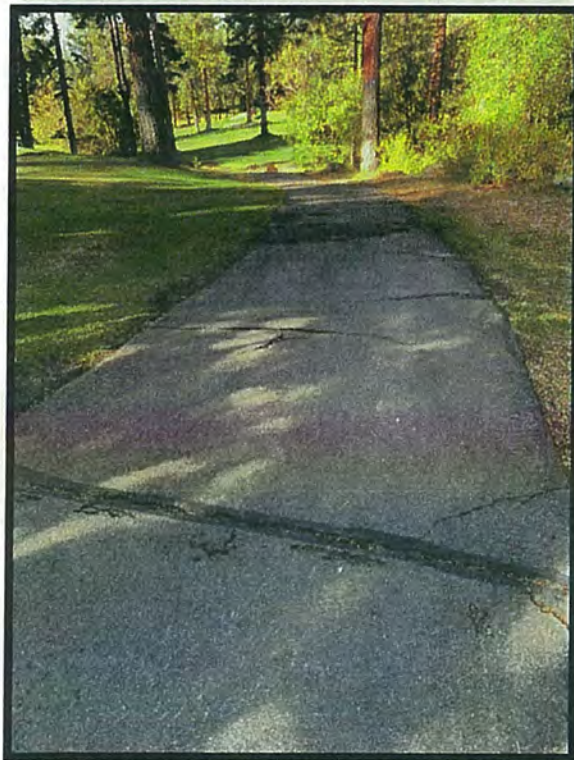
- Hole 10

- High severity transverse cracking
- Medium severity edge cracking

Recommended Repair

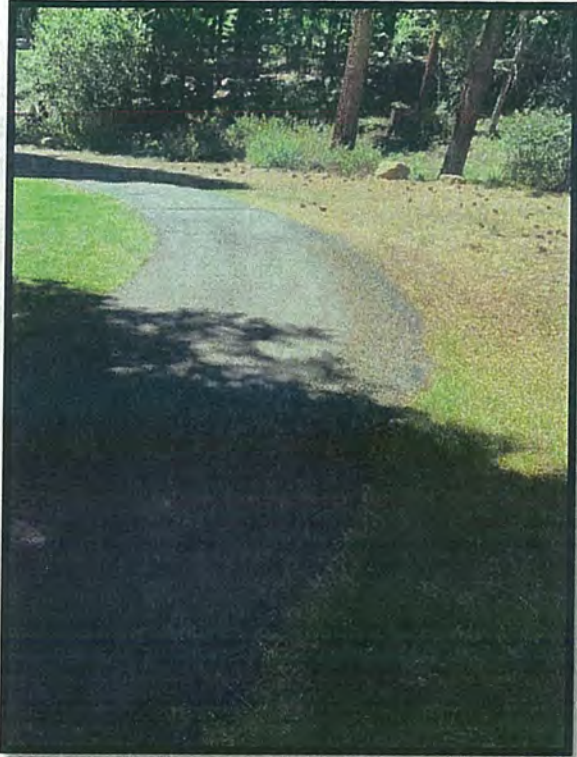
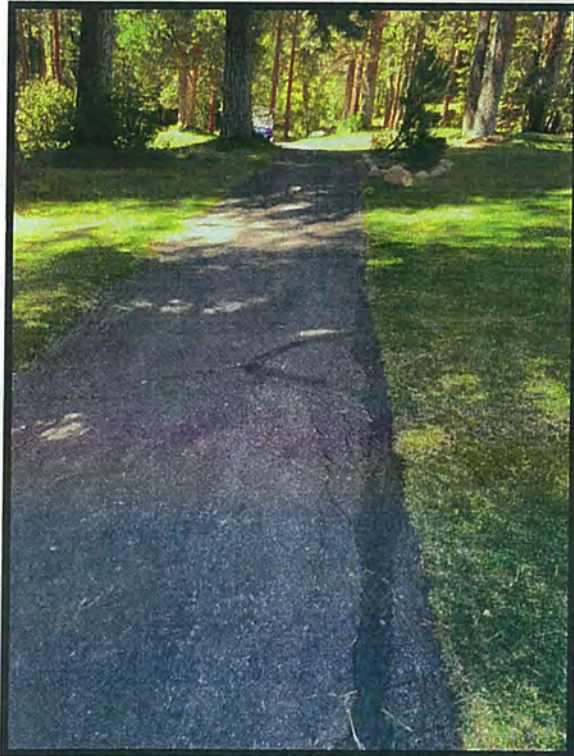
- Hole 10

- Medium severity transverse cracking
- High severity raveling
- Medium severity edge cracking

Recommended Repair

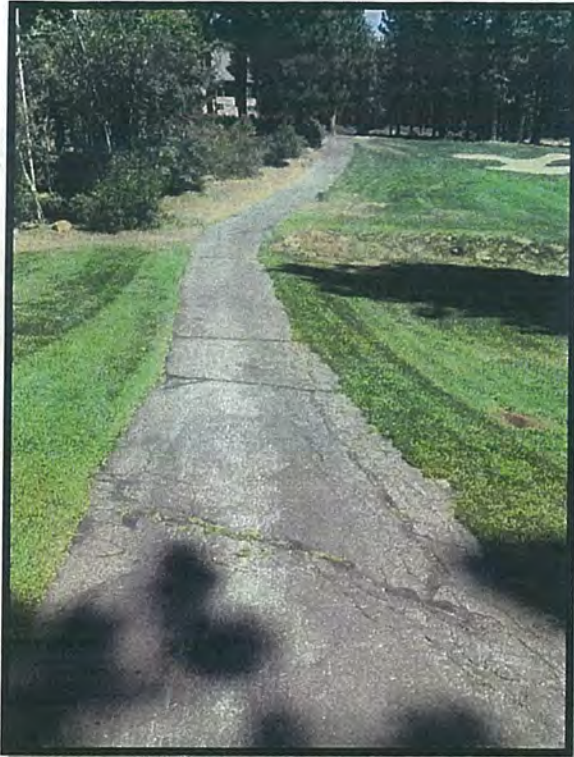
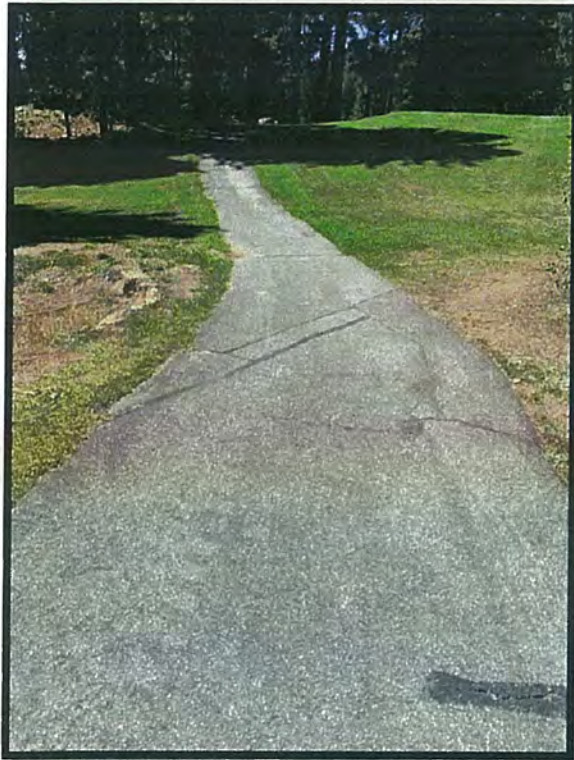
- Hole 11

- High severity transverse cracking
- High severity fatigue cracking

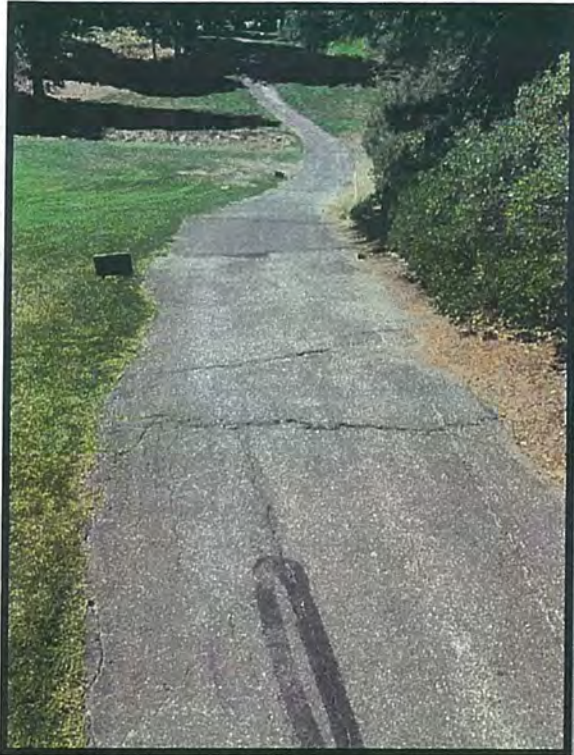
- Hole 11

- Medium severity transverse cracking
- Low severity fatigue cracking

- Unit Price - \$15 / SF (Reconstruction)
- Unit Price - \$1 / LF (Shouldering)
- 250-ft L x 8-ft W, 250-ft L x 1-ft W
- \$30,000 + \$250 = \$30,250

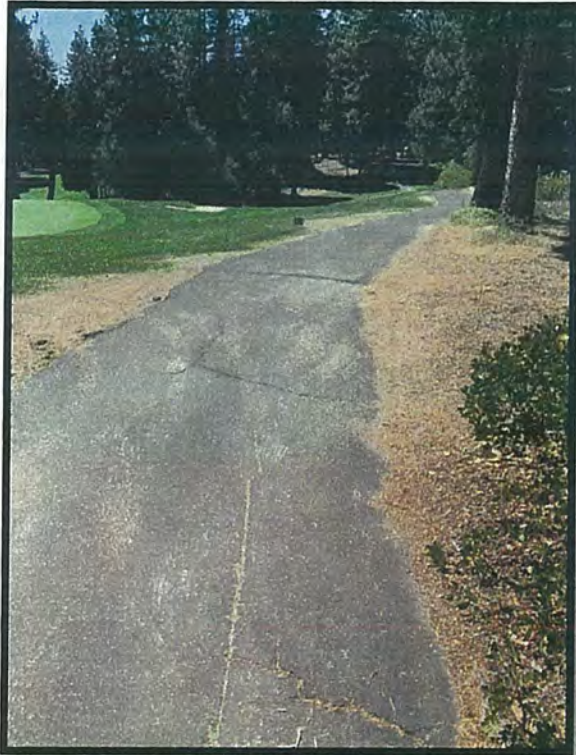
- Hole 11

- Medium severity transverse cracking
- Medium severity edge cracking

- Unit Price - \$15 / SF (Reconstruction)
- Unit Price - \$1 / LF (Shouldering)
- 50-ft L x 8-ft W, 100-ft L x 1-ft W
- \$6,000 + \$100 = \$6,100

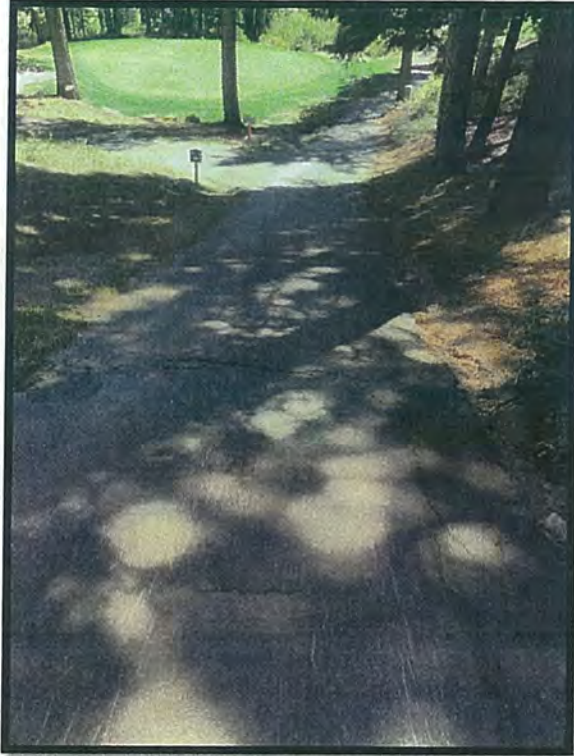
- Hole 12/13/15

- High severity transverse cracking
- Medium severity edge cracking

- Pavement Reconstruction
- 1-ft Wide Infiltration Trench, both sides of path (BMP)

- Unit Price - \$15 / SF (Reconstruction)
- Unit Price - \$18 / LF (Infiltration Trench)
- 80-ft L x 8-ft W, 160-ft L x 1-ft W x 10" D
- \$9,600 + \$2,880 = \$12,480

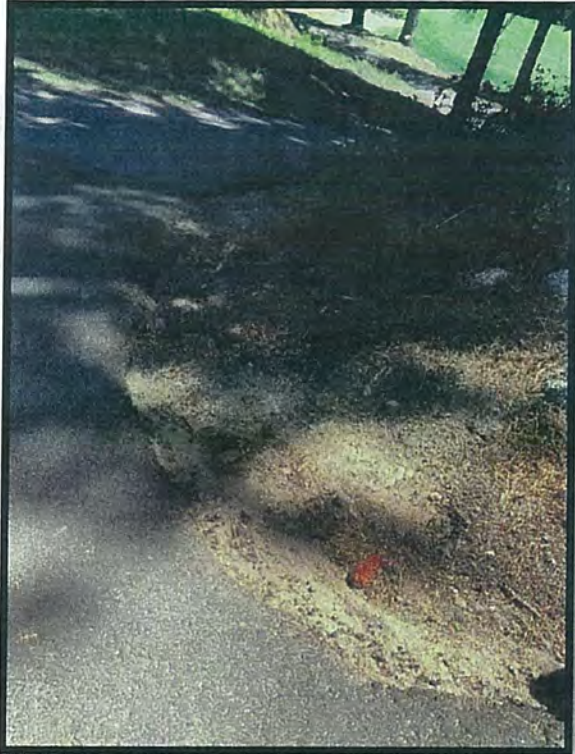
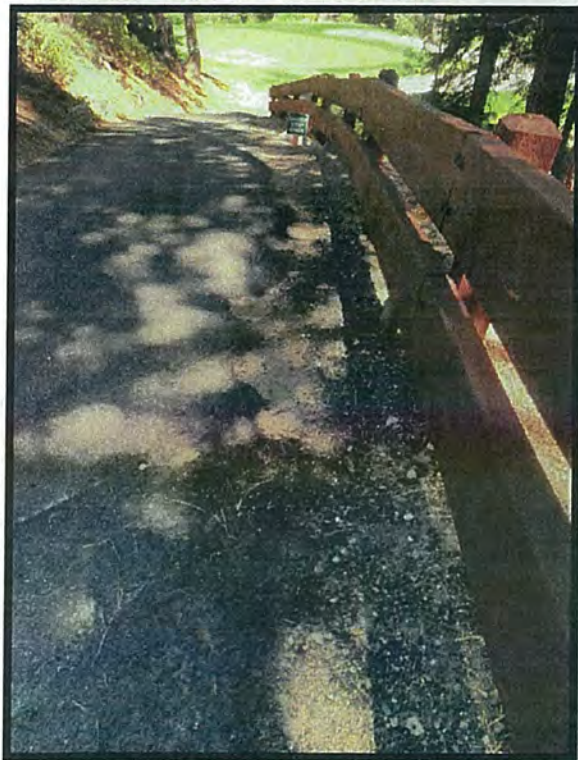
- Hole 12/13/15

- Low severity edge cracking

- Unit Price - \$1 / LF
- 130-ft L x 1-ft W
- \$130

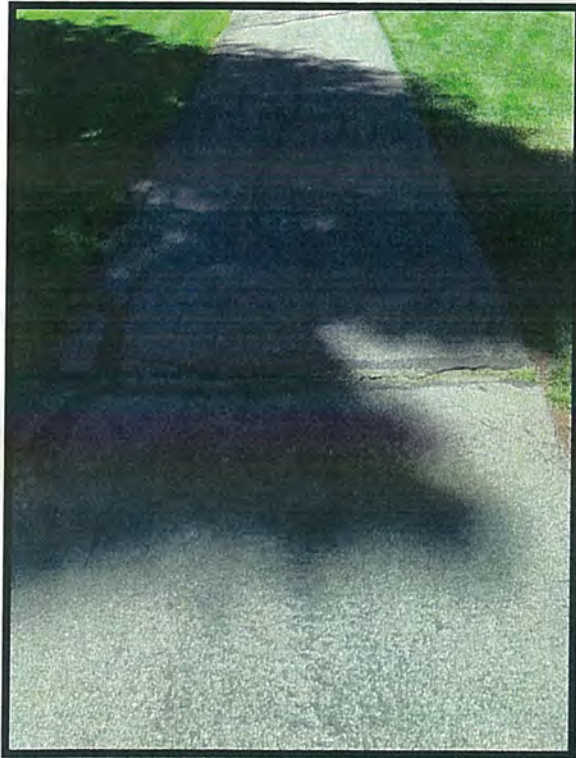
- Hole 13

- High severity transverse cracking
- Low severity fatigue cracking

- Unit Price - \$10 / SF
- 100-ft L x 8-ft W
- \$8,000

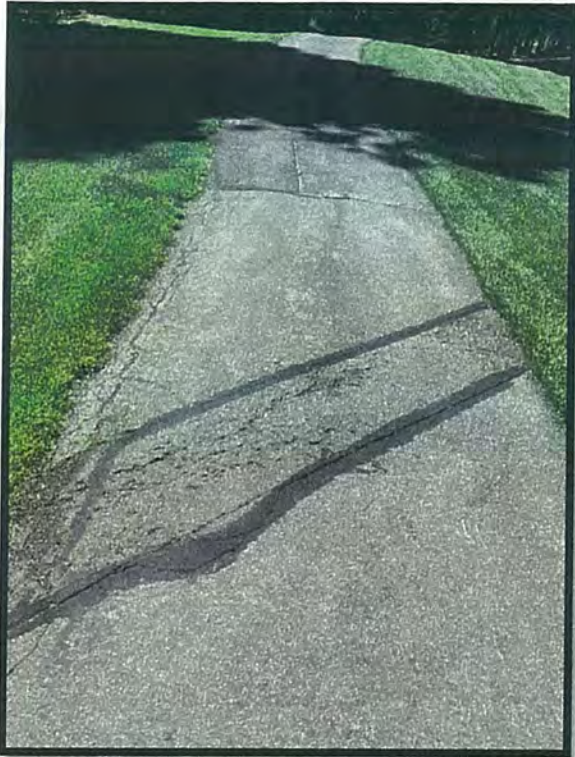
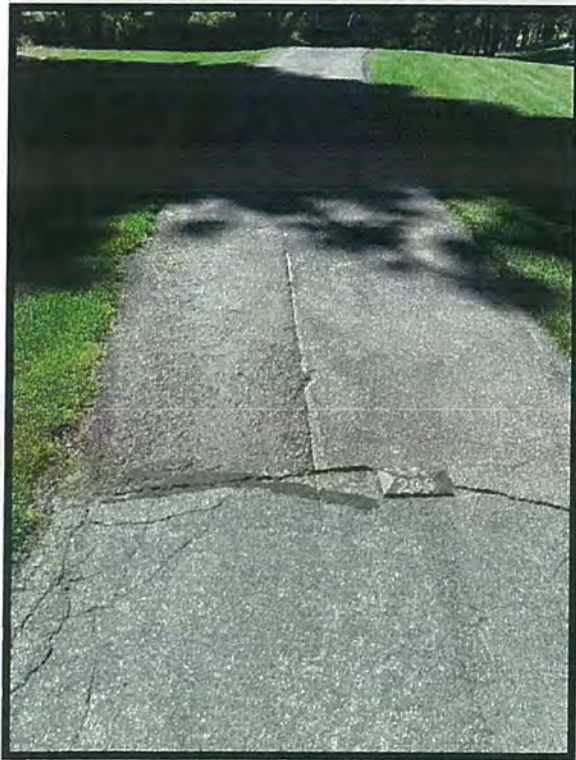
- Hole 13

- Medium severity edge cracking
- Medium severity raveling
- Low severity transverse cracking

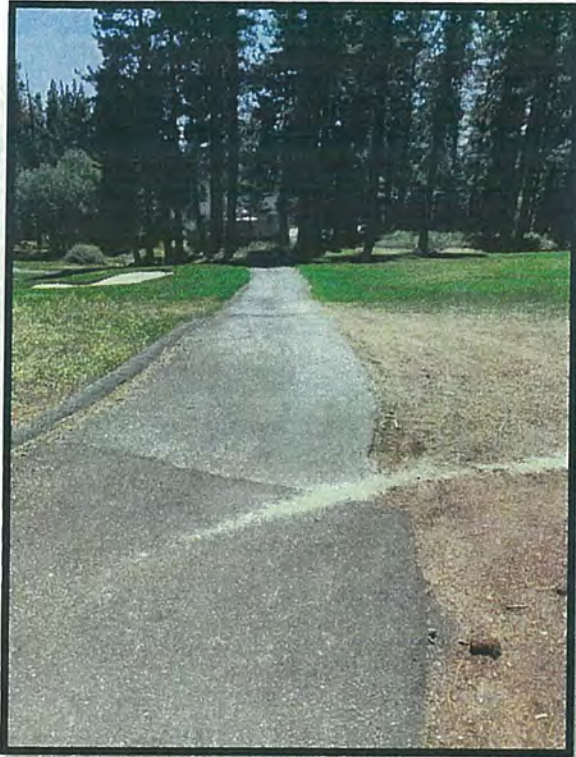
- Hole 13

- Medium severity transverse cracking
- Medium severity edge cracking

- Unit Price - \$15 / SF
- Unit Price - \$1 / LF
- 30-ft L x 8-ft W, 30-ft L x 1-ft W
- \$3,600 + \$30 = \$3,630

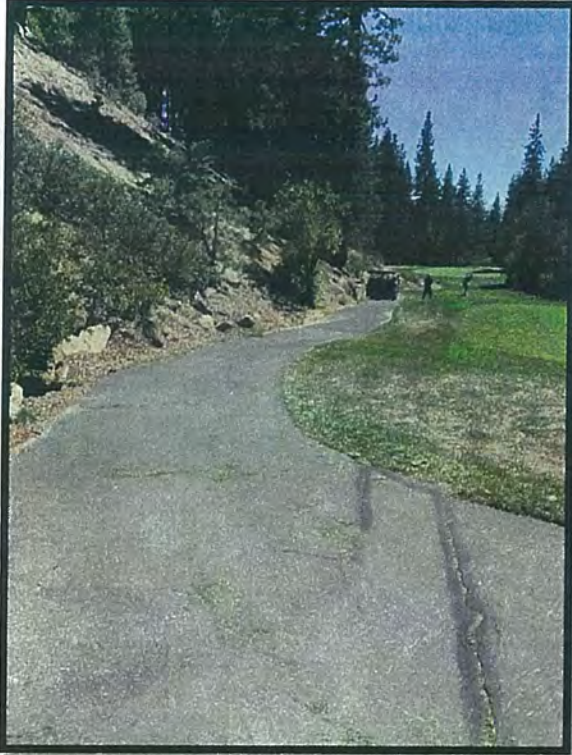
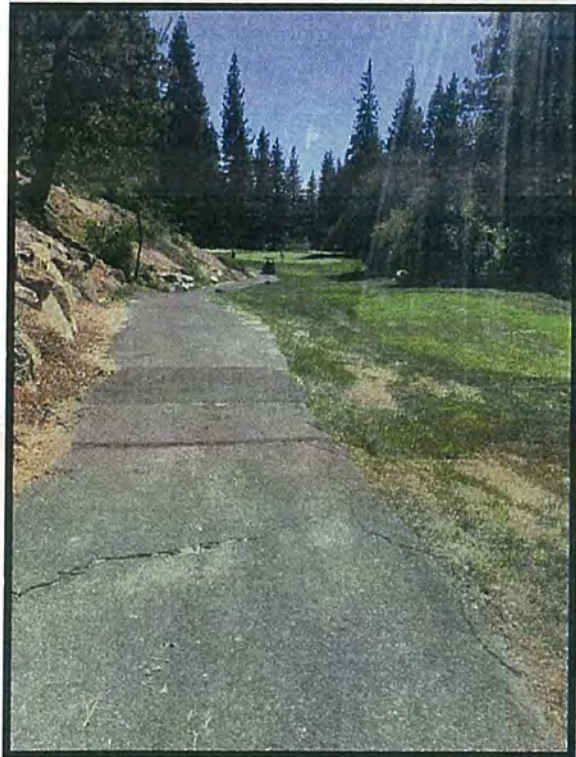
- Hole 16

- Medium severity transverse cracking
- Medium severity edge cracking
- Low severity fatigue cracking

- Unit Price - \$15 / SF
- 40-ft L x 8-ft W
- \$4,800

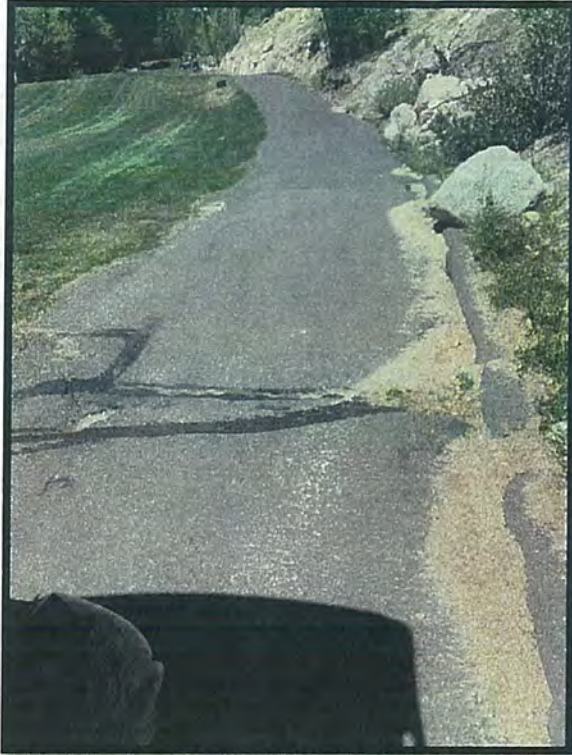
- Hole 16

- High severity transverse cracking
- Medium severity edge cracking

- Unit Price - \$15 / SF
- 20-ft L x 8-ft W
- \$2,400

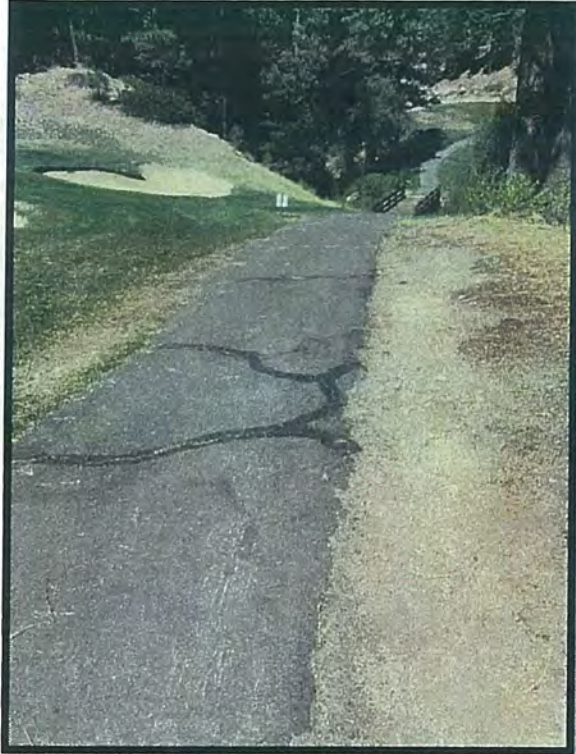
- Hole 17

- Medium severity transverse cracking

- Unit Price - \$15 / SF
- 25-ft L x 8-ft W
- \$3,000

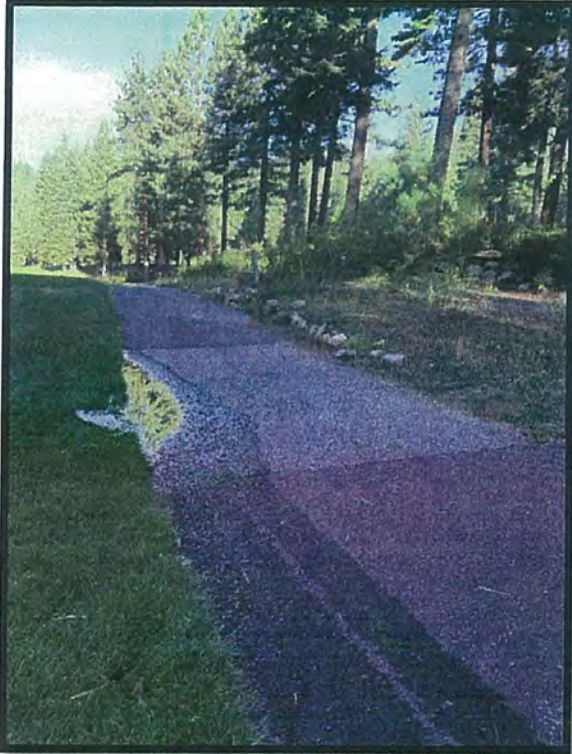
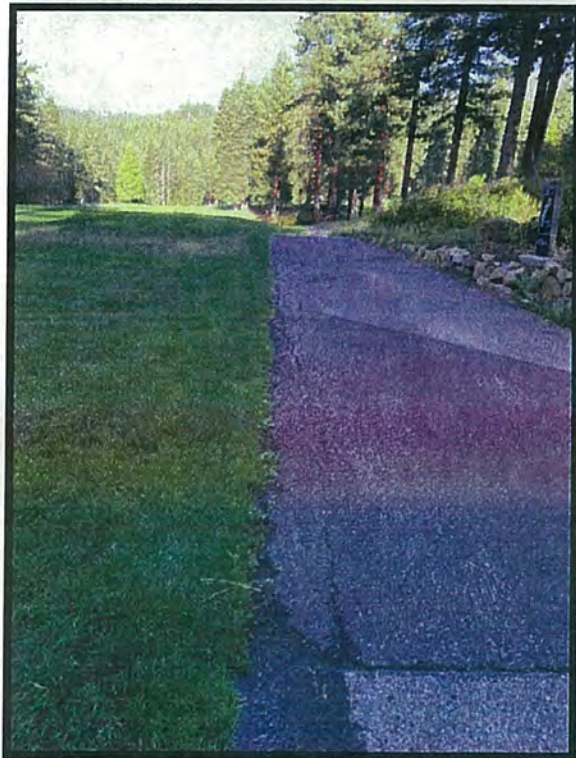
- Hole 18

- Medium severity edge cracking

- Full Depth Pavement Rehabilitation
- 1-ft Wide Infiltration Trench (BMP)

- Unit Price - \$10 / SF (Rehabilitation)
- Unit Price - \$18 / LF (Infiltration Trench)
- 230-ft L x 2-ft W, 230-ft L x 1-ft W x 10-in D
- \$4,600 + \$4,140 = \$8,740

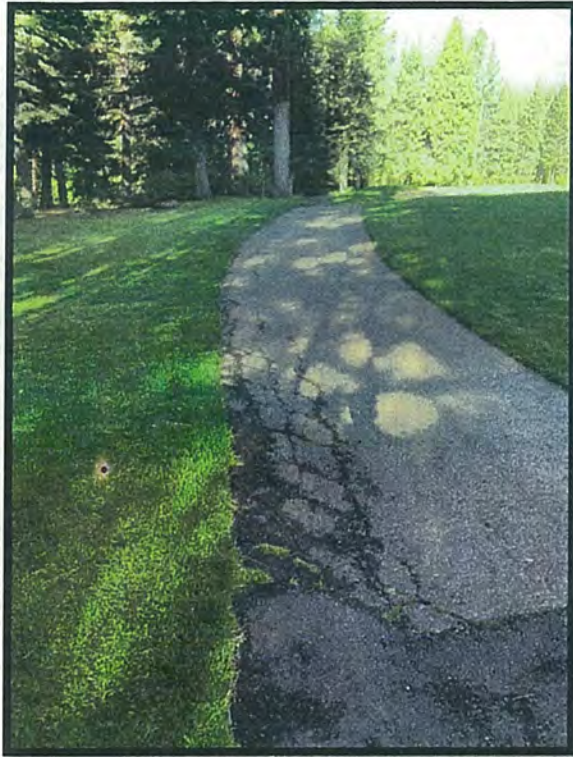
- Hole 18

- Medium severity edge cracking

- Full Depth Pavement Rehabilitation
- 1-ft Wide Infiltration Trench (BMP)

- Unit Price - \$10 / SF (Rehabilitation)
- Unit Price - \$18 / LF (Infiltration Trench)
- 30-ft L x 4-ft W, 30-ft L x 1-ft W x 10-in D
- \$1,200 + \$540 = \$1,740

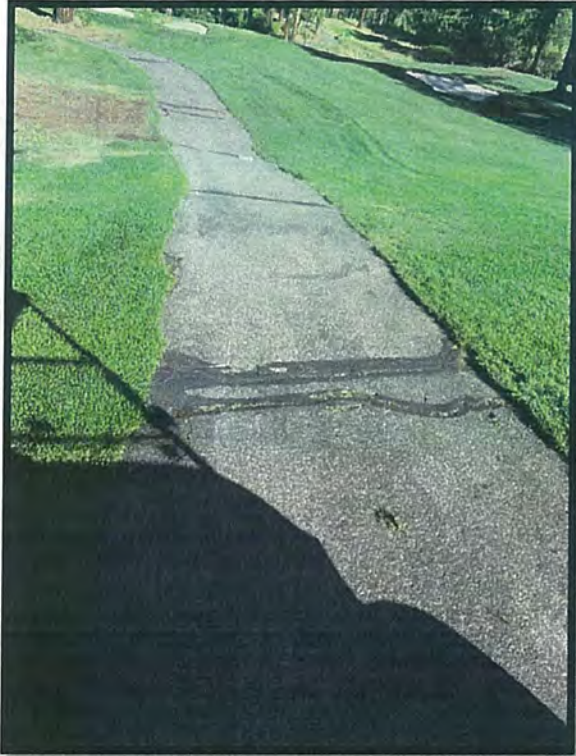
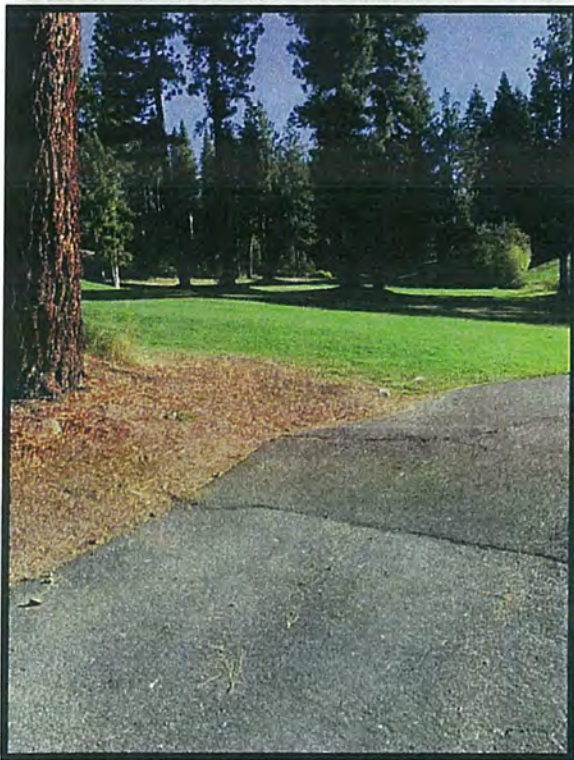
- Hole 18

- High severity transverse cracking

- Unit Price - \$10 / SF
- 230-ft L x 8-ft W
- \$18,400

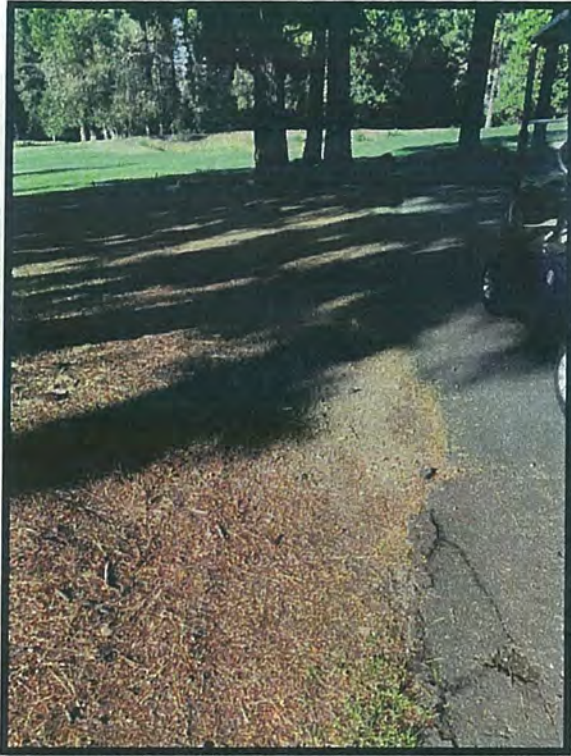
- Hole 18

- Medium severity edge cracking

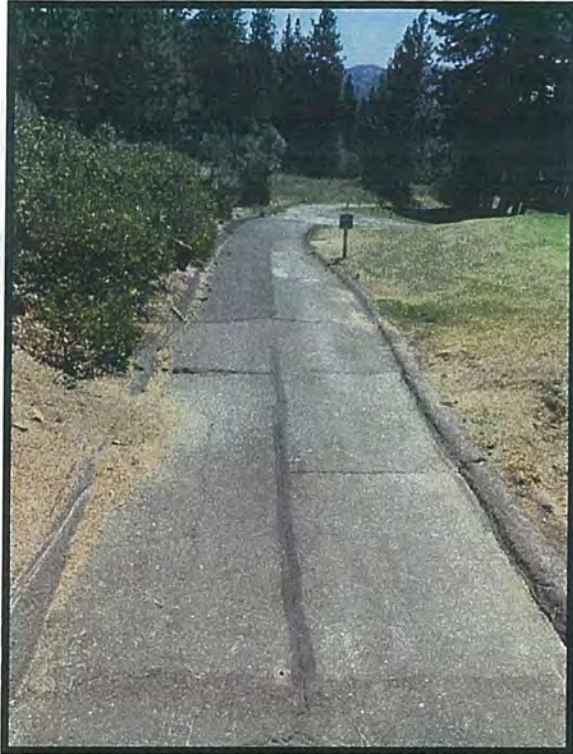
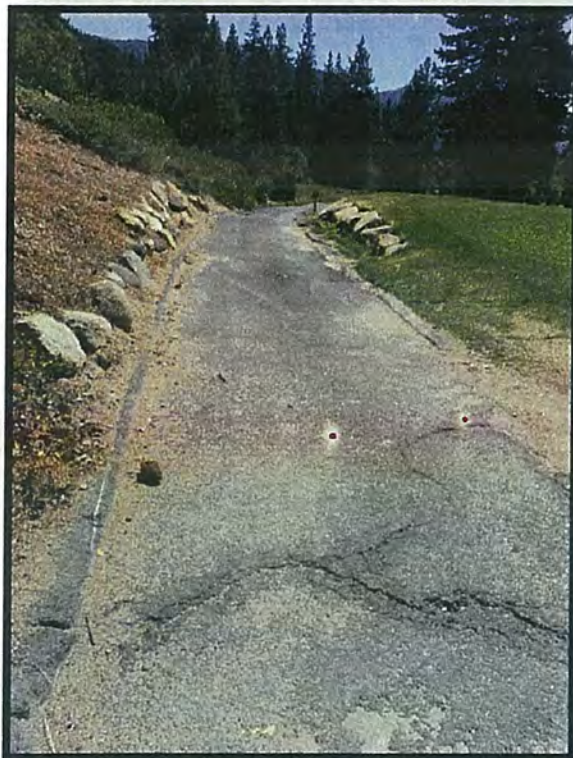
- Hole 2/3

- Medium severity transverse cracking
- Low severity longitudinal cracking

- Unit Price - \$15 / SF
- 125-ft L x 8-ft W
- \$15,000

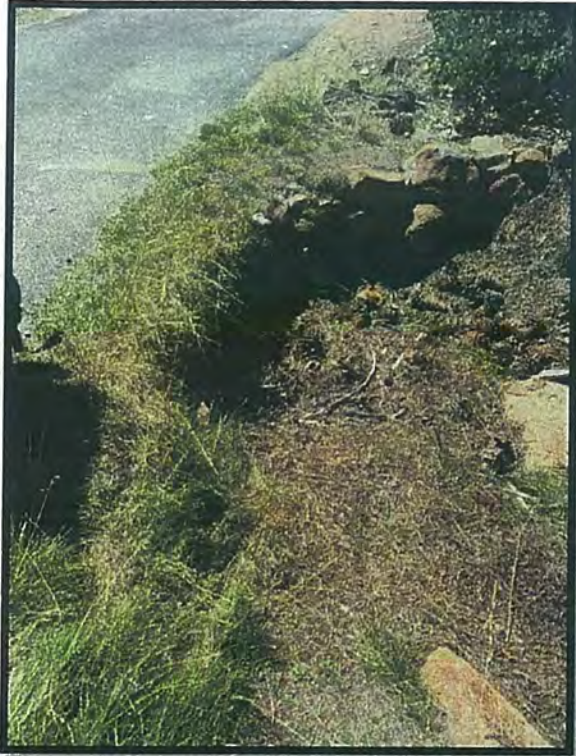
Location

- Hole 10

- Unit Price - \$1.00 / LF (Shouldering)
- Unit Price - \$25.00 / LF (Fencing or Guard Rail)
- 5-ft L x 1-ft W, 5-ft L x 3-ft H
- \$5 + \$125 = \$130

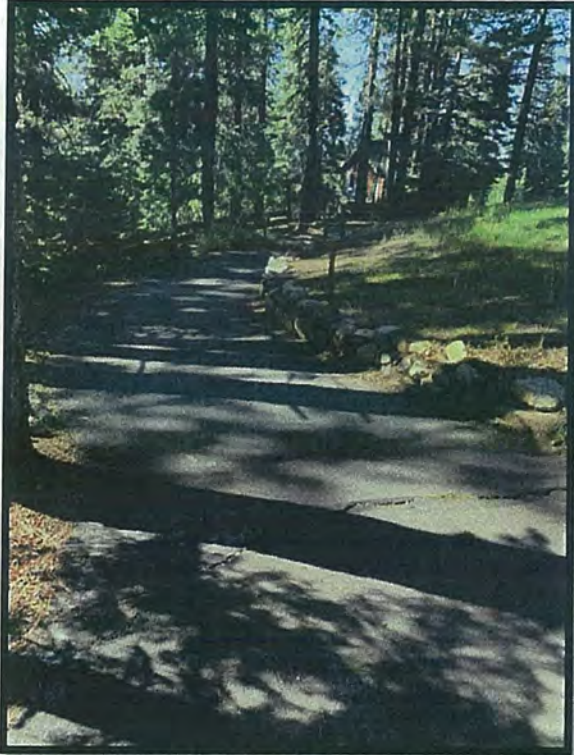
Location

- Hole 13

- Retaining wall is beginning to fail and is leaning toward the cart path.

- Drainage is causing retaining wall to lean and will eventually cause failure.

- Replace retaining wall with retaining wall + drainage rock

- Unit Price - \$50 / SF
- 40-ft L x 3-ft H
- \$6,000

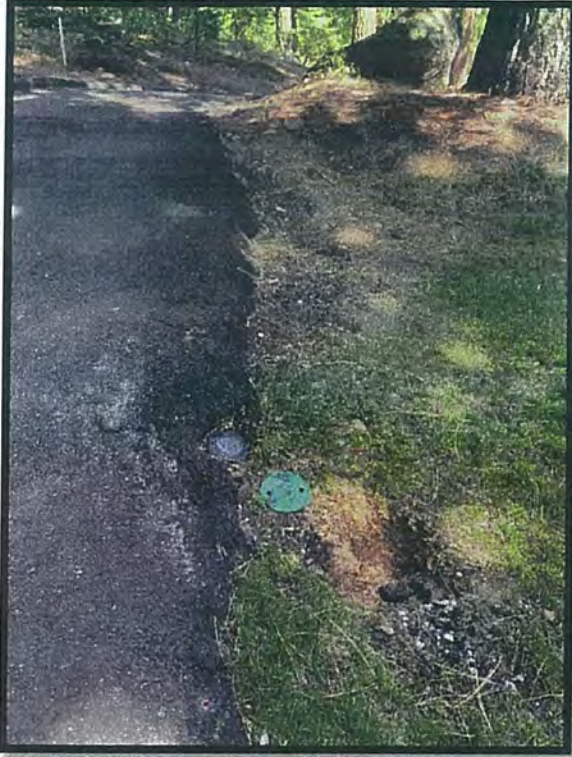
Location

- Hole 13/14

- Unit Price - \$1 / LF
- 10-ft L x 1-ft W
- \$10

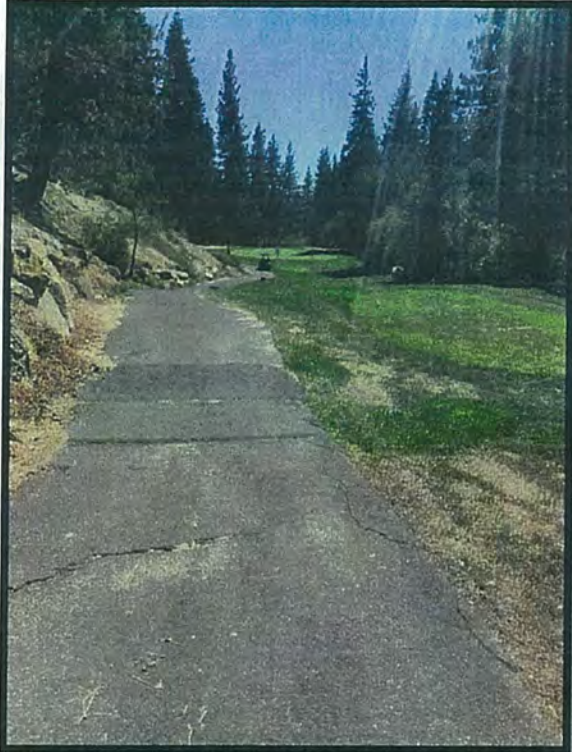
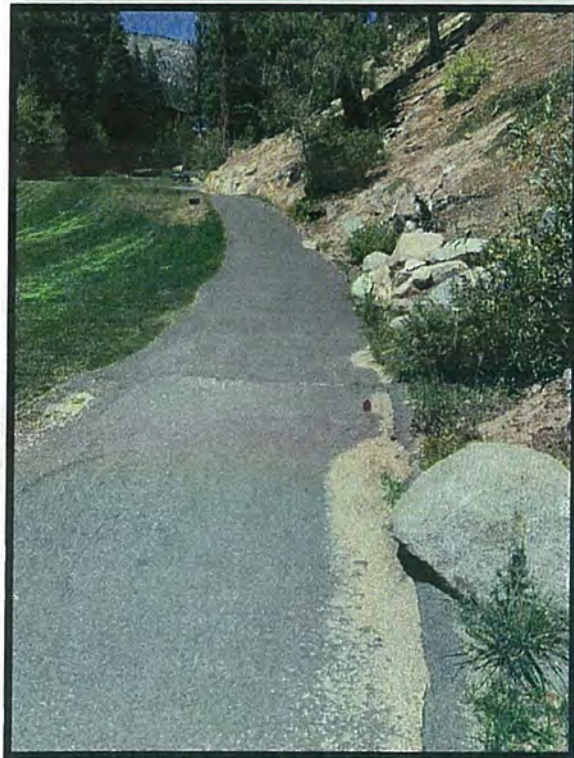
Location

- Hole 16

- No pavement edge stability. Edge cracking is beginning to occur.
- High slopes on uphill side of cart path

- Unit Price - \$20 / SF
- 225-ft L x 3-ft H
- \$13,500

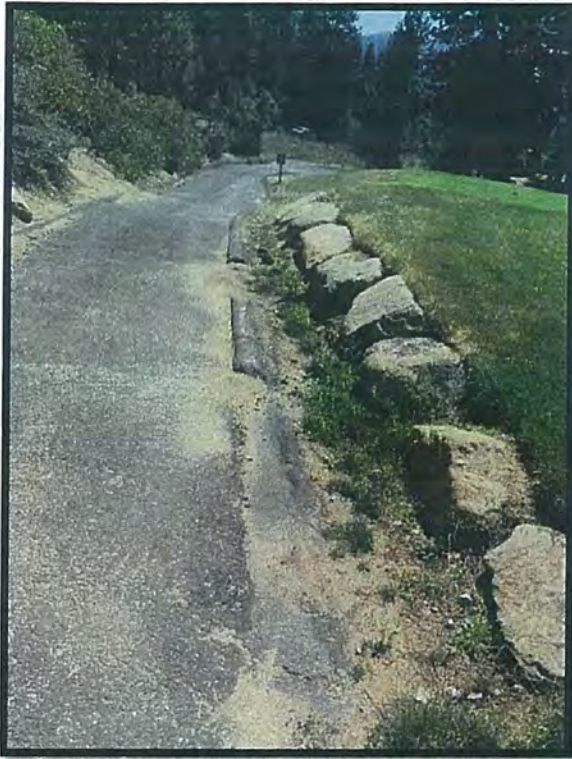
Location

- Hole 2/3

- 1-ft Wide Infiltration Trench (BMP)
